## status report

**customer:** Bank 11, Neuss  
**contract number:** 934788730-INSO  
**reference:**

#### Renault Trafic Kasten L1H1 2,8t Komfort

| Vehicle identification number | <b>VF1FL000869403681</b> | mileage read: | <b>30652 km</b> |

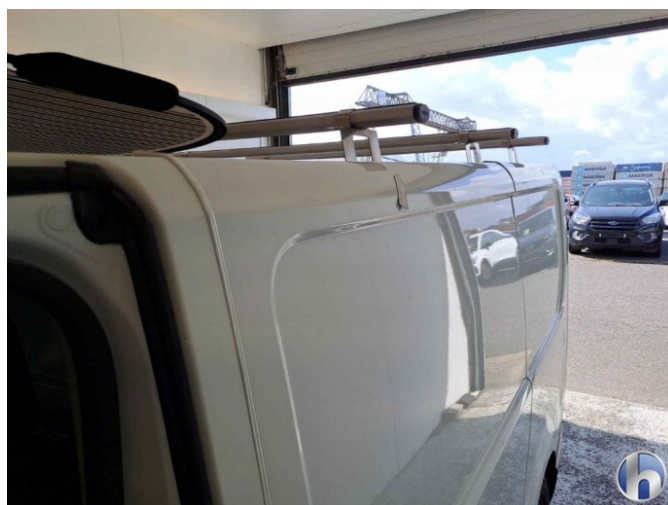
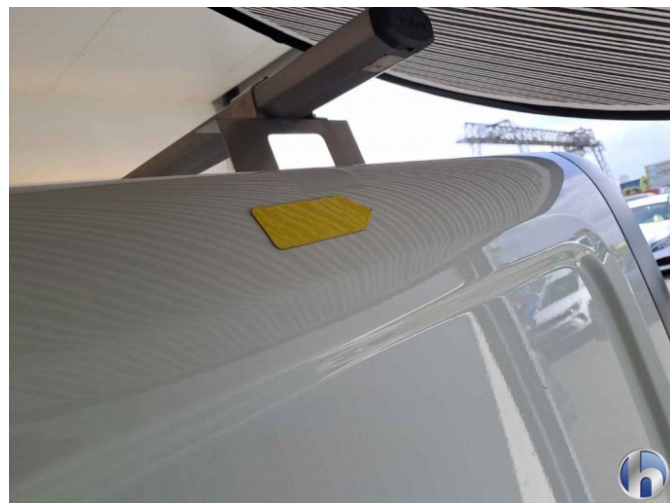
| Performed testing technology | |
|---|---|
| <b>reference:</b> | *Alters-, Transport- und Laufleistungsbedingte Gebrauchsspuren vorhanden. Es handelt sich um ein Nutzfahrzeug. Dementsprechend sind ggf. stärkere Gebrauchsspuren am und im Fahrzeug vorhanden. Kosten- und Schadenserweiterung möglich. Aufgrund der Höhe ist die Begutachtung vom Dach und der Dachrahmen nicht möglich. Schäden sind nicht ausgeschlossen. Aufgrund der Höhe ist die Lackmessung nur bedingt möglich. Schäden sind nicht ausgeschlossen. Die Lackschichtdicke ist erhöht. Die Stahlfelgen weisen Korrosion auf. Schäden sind nicht ausgeschlossen. Der Motor läuft mit erhöht Drehzahl und hat unnormale Geräusche. Schäden und Folgeschäden sind nicht ausgeschlossen. Das Dach und die Dachrahmen sind stark beschädigt. Weitere Schäden sind nicht ausgeschlossen. |

| component | Damage | Rep kind |
|---|---|---|
| 22. Roof frame - left | Damaged | Refurbish and paint |

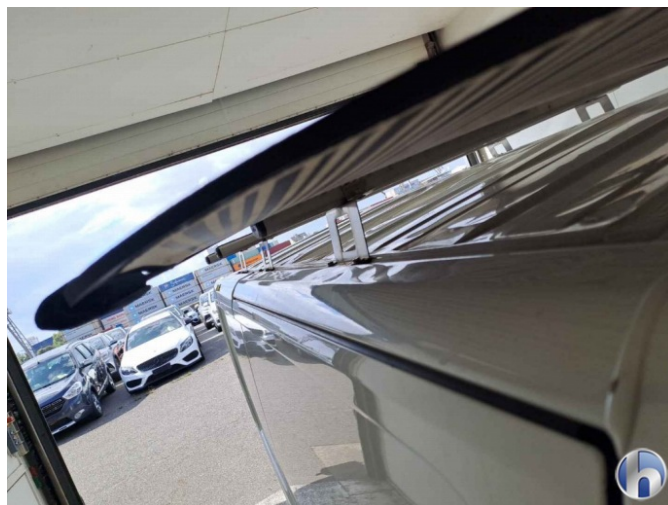
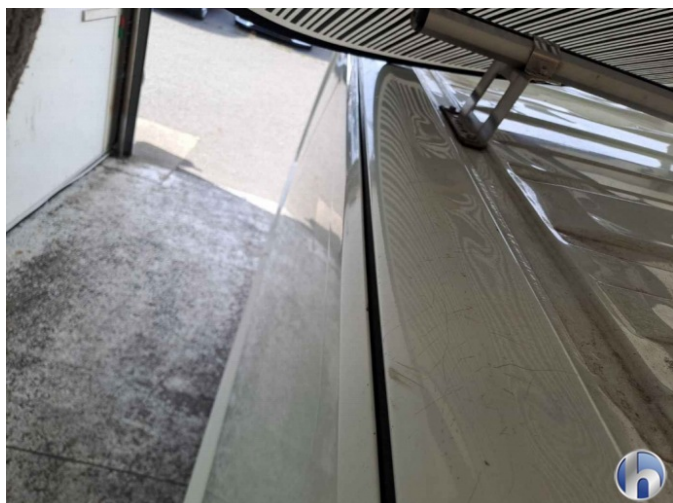
| component | Damage | Rep kind |
|---|---|---|
| 36. Roof frame - right | Damaged | Refurbish and paint |

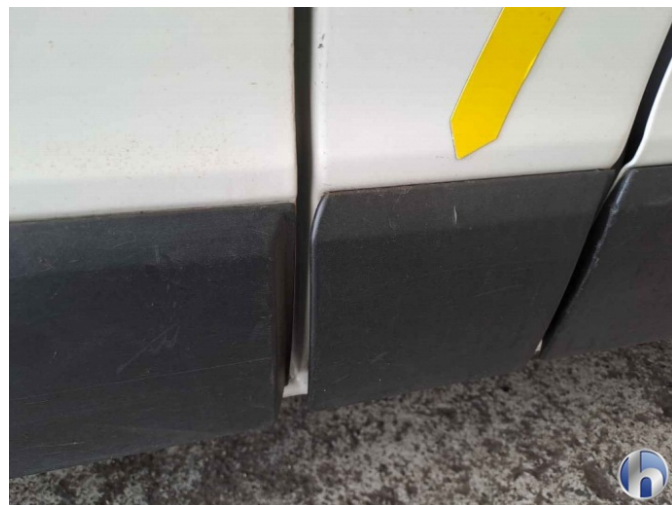
| component | Damage | Rep kind |
|---|---|---|
| 38. Tür Vorne - Rechts Beplankung | Scrape | Replace |
