## status report

#### Renault Trafic Kasten L1H1 2,8t Komfort

| Vehicle identification number | <b>VF1FL000969403673</b> | mileage read: | <b>26357 km</b> |

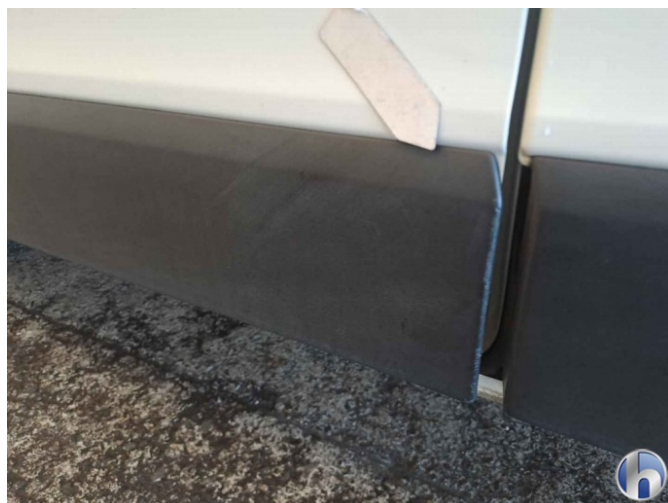
| component | Damage | Rep kind |
|---|---|---|
| 19. Tür Vorne - Links Beplankung | Scrape | Replace |
