RENAULT TRAFIC COMBI  
Trafic L2 dCi 170 Energy S&S EDC Intens

VIN NO VF1JL000172821570  
Registration Number GW828FR

Inspection Report Summary

| Customer | BCAuto Encheres | Report Number | P20251008143149 |

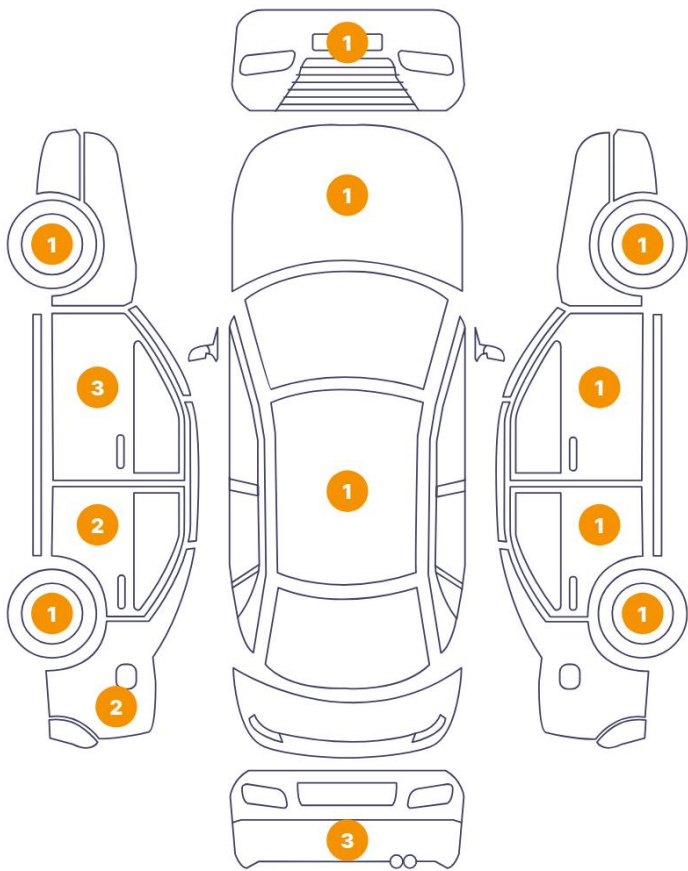
19 Dommages

| Component | Damage | Comments |
|---|---|---|
| 4 Roof | Bodywork / Poor Previous Repair | Ruban adhésif ( dégât sous réserve de diagnostic ) |
| 7 Bumper / Front | Missing Part | |

| 17 Mirror / Front Left | Missing Part |
| 18 Door Handle / Front Left | Missing Part |
