## status report

#### Renault Master III Kasten L2H2 HKa 3,5t

| Vehicle identification number | <b>VF1MAF4SC56045620</b> | mileage read: | <b>126169 km</b> |

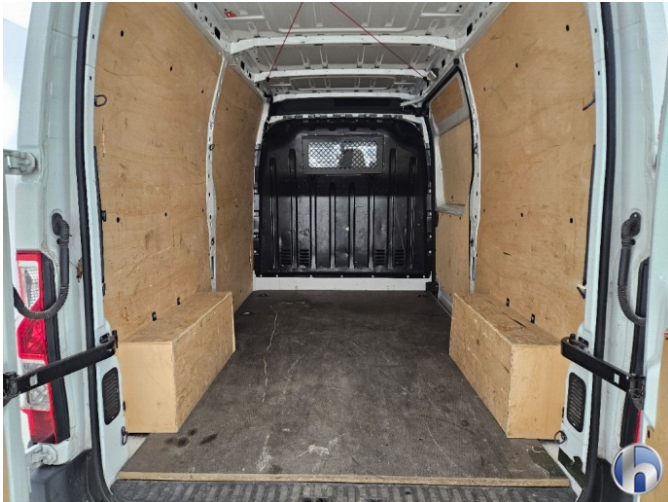
trunk

| | <b>component</b> | <b>Damage</b> | <b>Rep kind</b> |
|---|---|---|---|
| 7. | Laderaum | Wear and tear | acceptable |

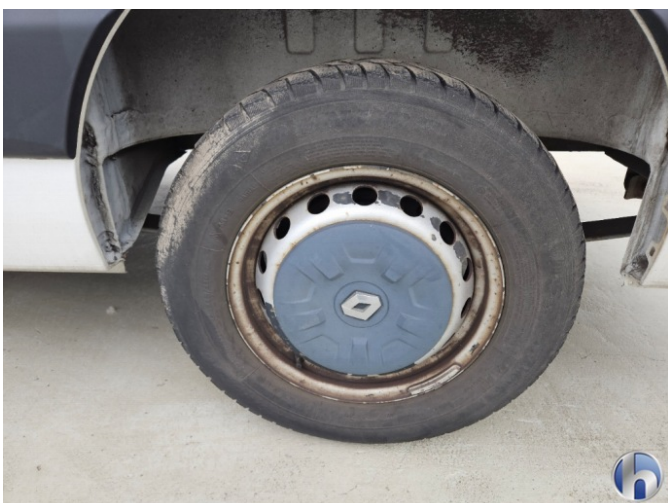
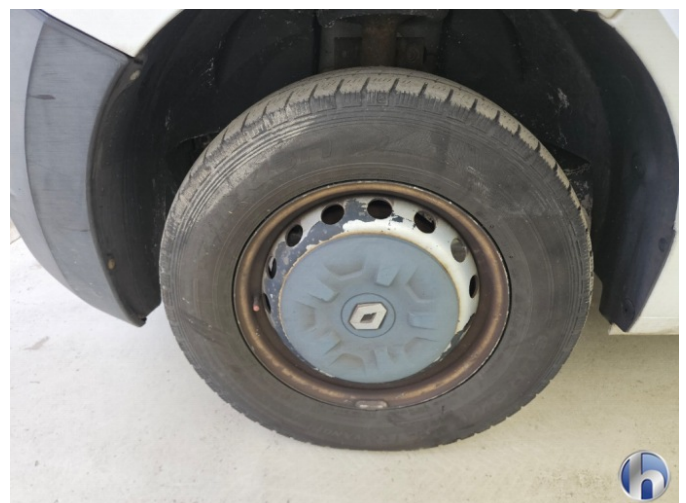
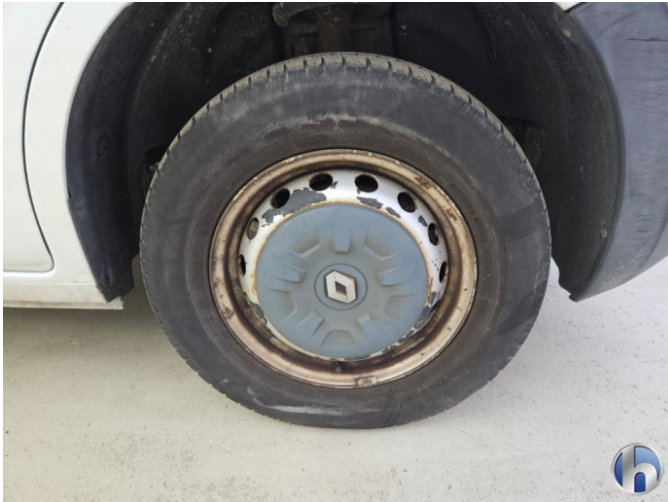
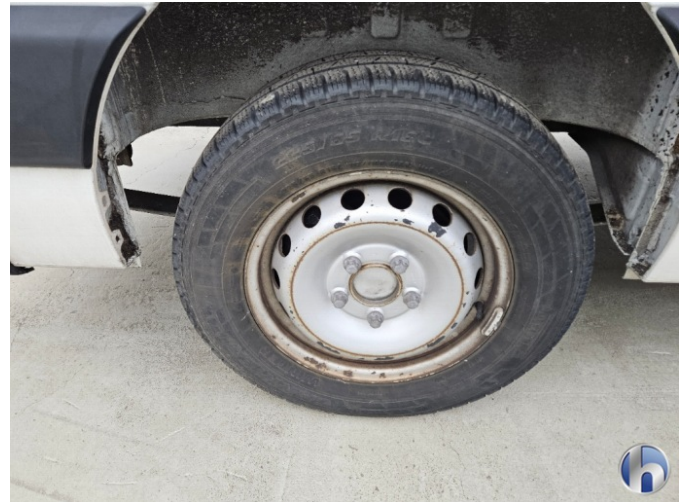
rims

| | <b>component</b> | <b>Damage</b> | <b>Rep kind</b> |
|---|---|---|---|
| 6. | Reifen 4x | Not safe for road traffic | Replace |

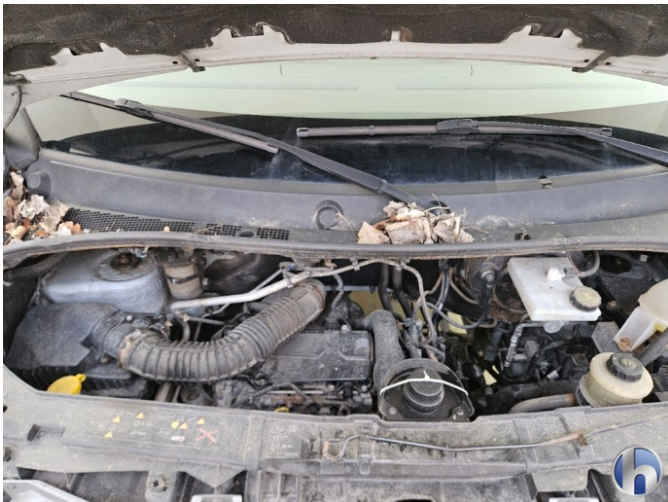
engine compartment

| | <b>component</b> | <b>Damage</b> | <b>Rep kind</b> |
|---|---|---|---|
| 4. | Motordämmmaterial | Damaged | Replace |
| 5. | Motorraum | Wear and tear | acceptable |
