Expertise

Protocol number: 41585716  
Order No. / Reference: 25179191  
Inspection date: 16 Sept 2025

Manufacturer: Renault

Model: Talisman Grandtour BLUE dCi 150 BUSINESS EDITION

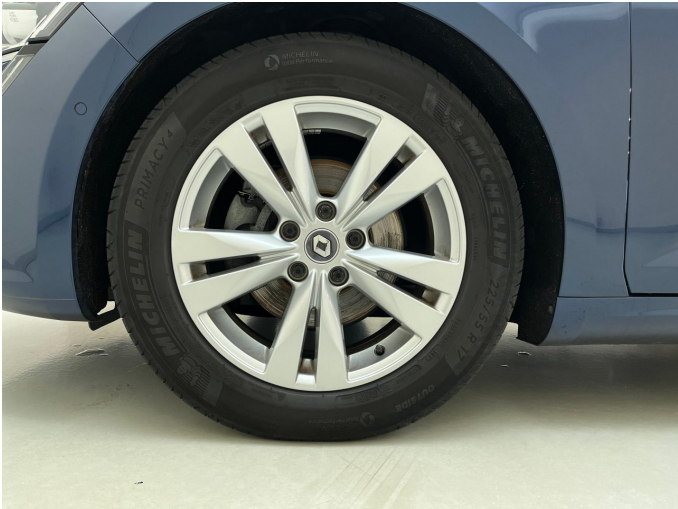
Figure 12: Mounted tyres

#	Tyre size	Type of tyre	Manufacturer	Tread depth
1)	225/55 R17 101W	Summer tyres on Light alloy	Michelin	4mm / 4mm
2)	225/55 R17 101W	Summer tyres on Light alloy	Michelin	5mm / 5mm

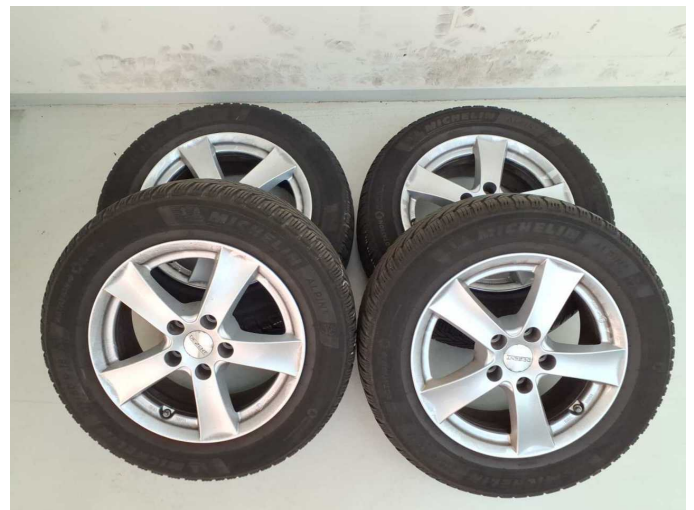
Figure 16: Additional tyres

#	Tyre size	Type of tyre	Manufacturer	Tread depth
1)	215/60 R16 99H	Winter tyres on Light alloy	Michelin	5mm / 5mm
2)	215/60 R16 99H	Winter tyres on Light alloy	Michelin	7mm / 7mm
