## status report

**customer:** Bank 11, Neuss  
**contract number:** 807114430  
**reference:**

#### Renault Kadjar Intens

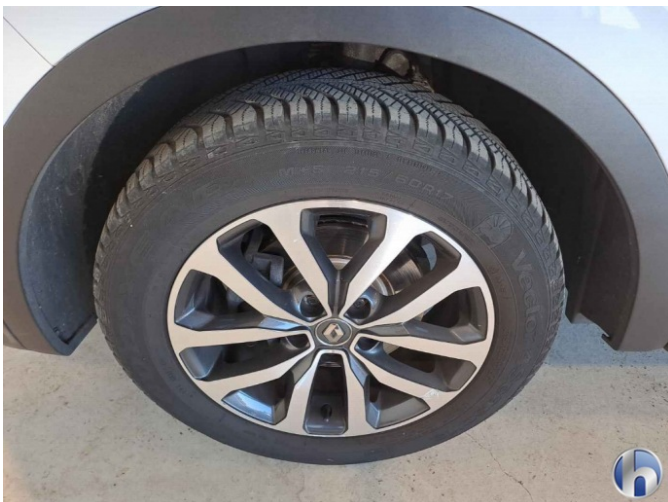
rims

| component | Damage | Rep kind |
|---|---|---|
| 9. Rim front - left | Damaged | Replace |

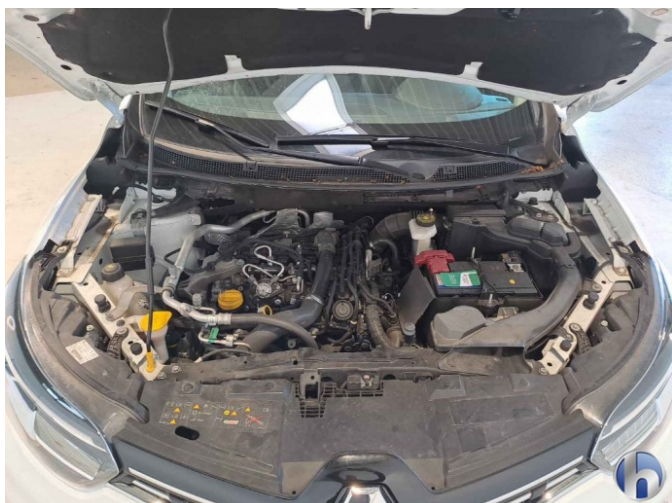
engine compartment

| Performed testing technology | |
|---|---|
| <b>reference:</b> | *Fahrzeug hat Alter und Laufleistungs bedingte Gebrauchsspuren innen und außen Marderbiss<br>Motorraum Unfallschaden Stoßfänger vorne Schaden und Kosten Erweiterung möglich |
