RENAULT ARKANA

Arkana TCe 140 EDC - 23 Techno

VIN NO VF1RJL009UC489586
Registration Number GX863EP

Inspection Report Summary

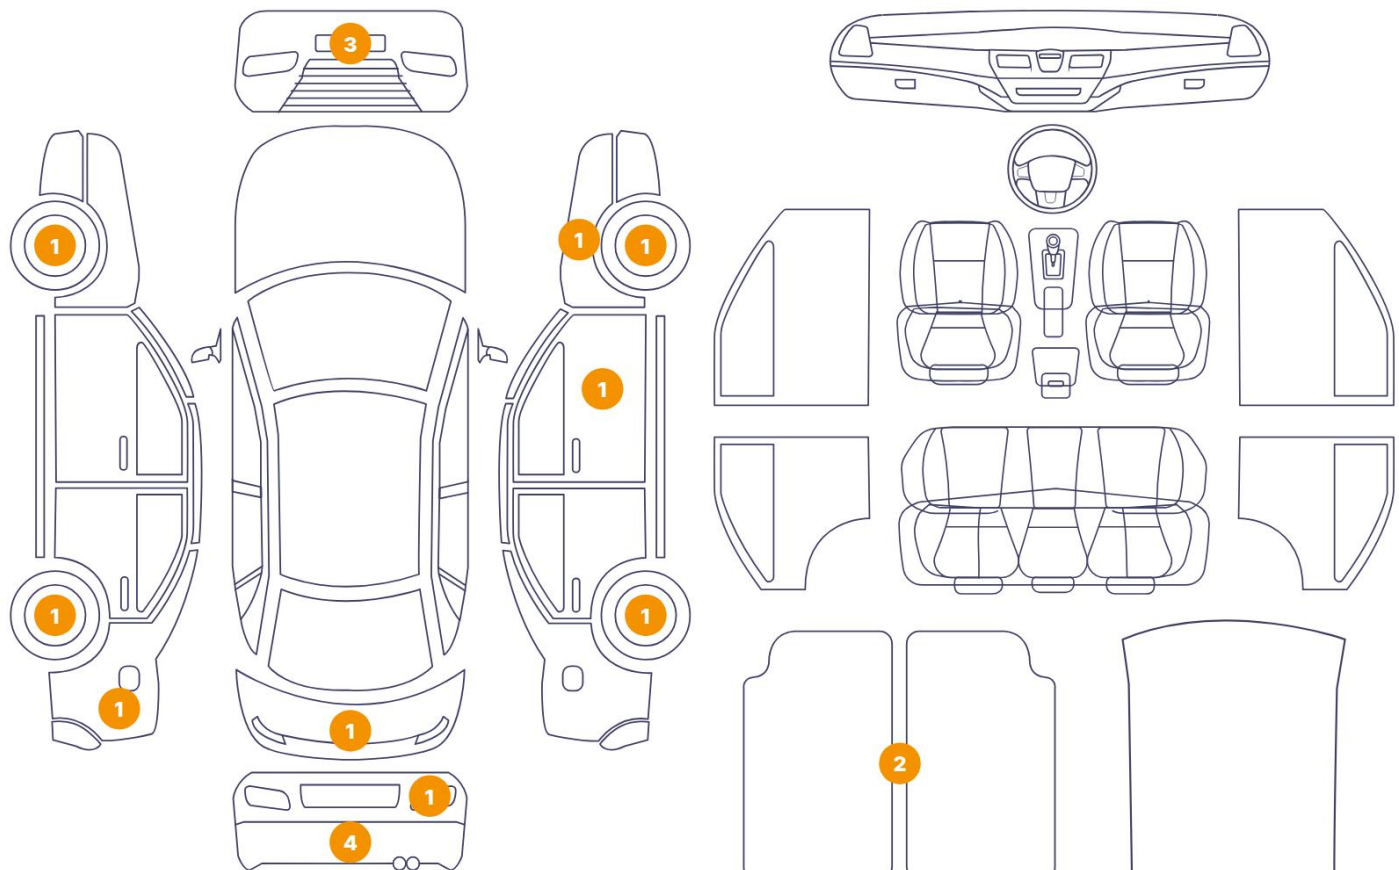
Component	Damage	Comments
1 Floor Carpet	Interior / Dirty	
2 Floor Carpet	Interior / Dirty	
3 Corner Bumper / Front Right	Paint / Scratch / Scuff	
4 Bumper / Front	Paint / Scratch / Scuff	
5 Corner Bumper / Front Left	Paint / Scratch / Scuff	
6 Rim / Front Left	Out of Bodywork / Scratch	
7 Side Panel / Back Left	Bodywork / Assembly	
8 Rim / Back Left	Out of Bodywork / Scratch	
9 Corner Bumper / Back Left	Missing Part	
10 Corner Bumper / Back Left	Bodywork / Dent / Deformation	
11 Bumper / Back	Bodywork / Dent / Deformation	
12 Tailgate	Bodywork / Dent / Deformation	
13 Corner Bumper / Back Right	Bodywork / Dent / Deformation

14	Back Light / Right	Missing Part
15	Rim / Back Right	Out of Bodywork / Scratch
16	Mirror / Front Right	Paint / Scratch / Scuff
17	Fender / Front Right	Paint / Scratch / Scuff
18	Rim / Front Right	Out of Bodywork / Scratch
