Expertise

Protocol number: 41601312
Order No. / Reference: 25101426
Inspection date: 17 Sept 2025

Manufacturer: Renault	Model: Kangoo Rapid Blue dCi 95 Extra
VIN: VF1WF000465656933

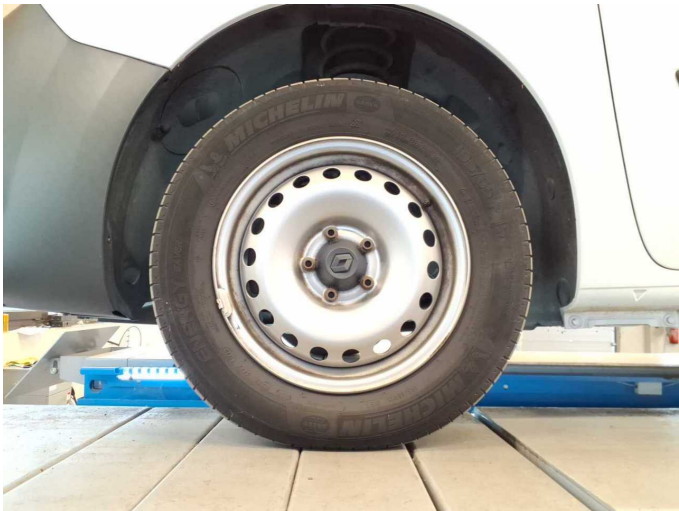
Figure 12: Mounted tyres

#	Tyre size	Type of tyre	Manufacturer	Tread depth
1)	195/65 R15 95T	Summer tyres on Steel rim with wheel cover	Michelin	6mm / 6mm
2)	195/65 R15 95T	Summer tyres on Steel rim with wheel cover	Michelin	5mm / 5mm

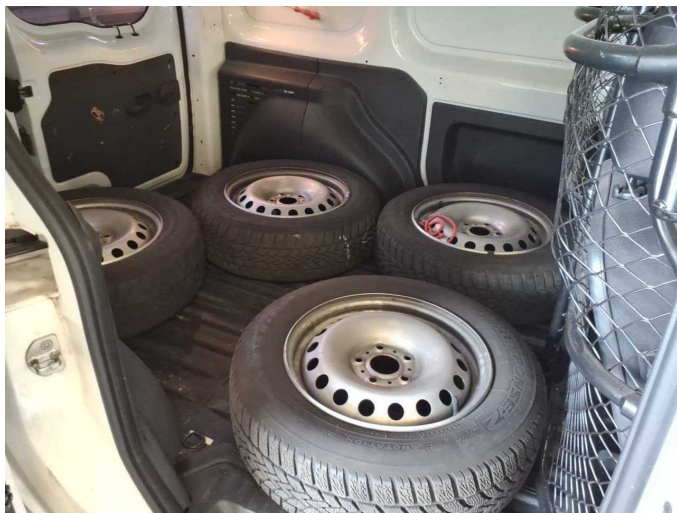
Figure 15: Additional tyres

#	Tyre size	Type of tyre	Manufacturer	Tread depth
1)	195/65 R15 95T	Winter tyres on Steel	Dunlop	5mm / 5mm
2)	195/65 R15 95T	Winter tyres on Steel	Dunlop	5mm / 5mm
