PEUGEOT 407 COUPE

407 Coupé 2.7 HDi 24v FAP Sport Pack A

VIN NO VF36JUHZJ21334949
Registration Number CM540SM

Customer	BCA Auto Encheres	Report Number	P20250701163139
Inspection Date / Place	2025-07-01 / BCA BETHUNE	Cosmetic Grade	4

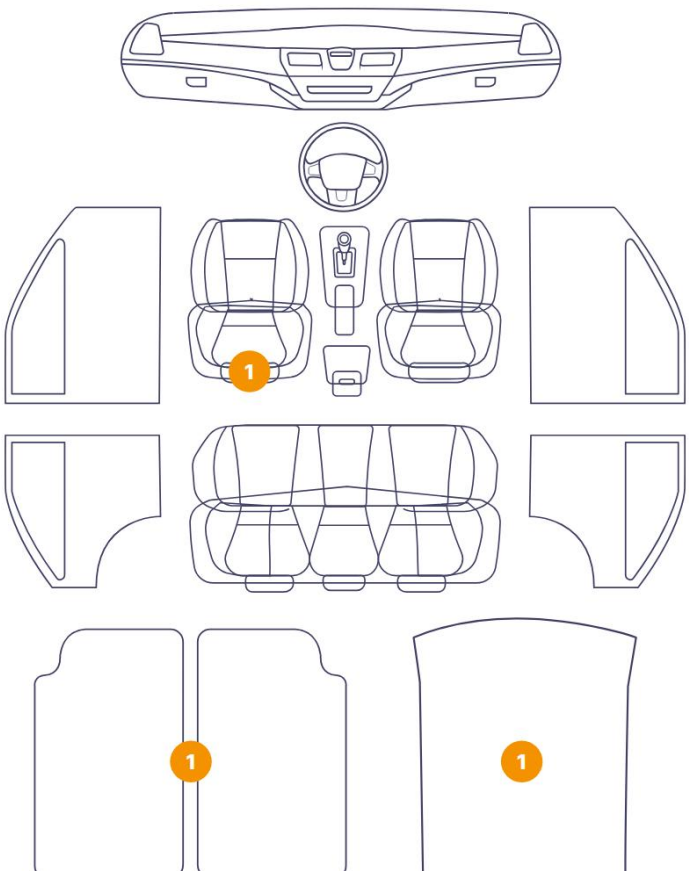
3 Dommages

Component		Damage	Comments
1	Floor Carpet	Interior / Dirty	
2	Backrest Cover / Front Left	Interior / Holed	
3	Roof Upholstery	Interior / Loose	
4	Corner Bumper / Front Right	Paint / Scratch / Scuff	
5	Bumper / Front	Paint / Scratch / Scuff	
6	Corner Bumper / Front Left	Paint / Scratch / Scuff	
7	Blade/spoiler / Front	Bodywork / Breakage	
8	Fender / Front Left	Paint / Scratch / Line	
9	Rim / Front Left	Out of Bodywork / Scratch	
10	Door / Front Left	Paint / Scratch / Line	
11	Rim / Back Left	Out of Bodywork / Scratch	
12	Corner Bumper / Back Left	Paint / Scratch / Scuff	
13	Bumper / Back	Paint / Scratch / Scuff

14	Tailgate	Paint / Chipping
15	Tailgate	Paint / Scratch / Line
16	Corner Bumper / Back Right	Paint / Scratch / Scuff
17	Corner Bumper / Back Right	Bodywork / Breakage
18	Side Panel / Back Right	Paint / Scratch / Line
19	Rim / Back Right	Out of Bodywork / Scratch
20	Side Panel / Back Right	Paint / Scratch / Line
21	Mirror / Front Right	Paint / Scratch / Scuff
22	Fender / Front Right	Paint / Scratch / Line
23	Rim / Front Right	Out of Bodywork / Scratch
