## status report

#### Peugeot 308 SW Style

| Vehicle identification number | <b>VF3LRHNSTKS240512</b> | mileage read: | <b>86875 km</b> |
| First Registration / construction year: | <b>10.07.2019 / 2019</b> | Visit Date / place of birth: | <b>25.09.2025 Riedstadt-Goddelau</b> |

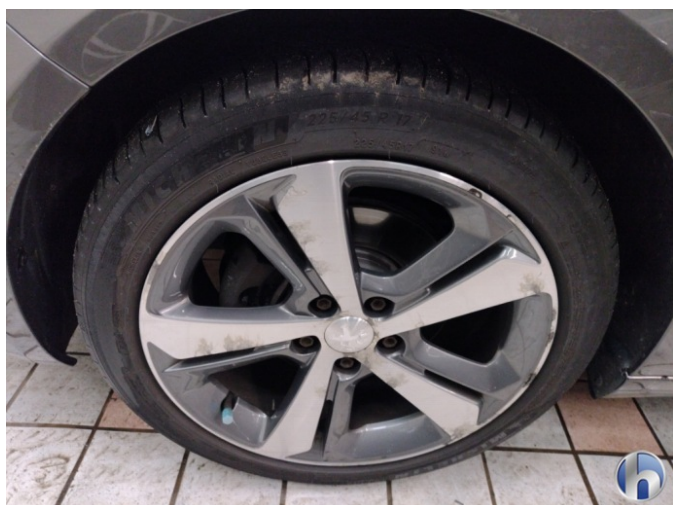
rims

| component | Damage | Rep kind |
|---|---|---|
| 2. Rim front - left | Damaged | Replace |
| 3. Rim rear - left | Damaged | Replace |
| 4. Rim rear - right | Damaged | Replace |
| 5. Rim front - right | Damaged | Replace |
