CITROEN C4 CACTUS

C4 Cactus PureTech 110 S&S BVM6 Shine

Inspection Report Summary

Customer	BCAuto Encheres	Report Number	P20250731140512
Inspection Date / Place	2025-07-31 / BCA BETHUNE	Cosmetic Grade	1

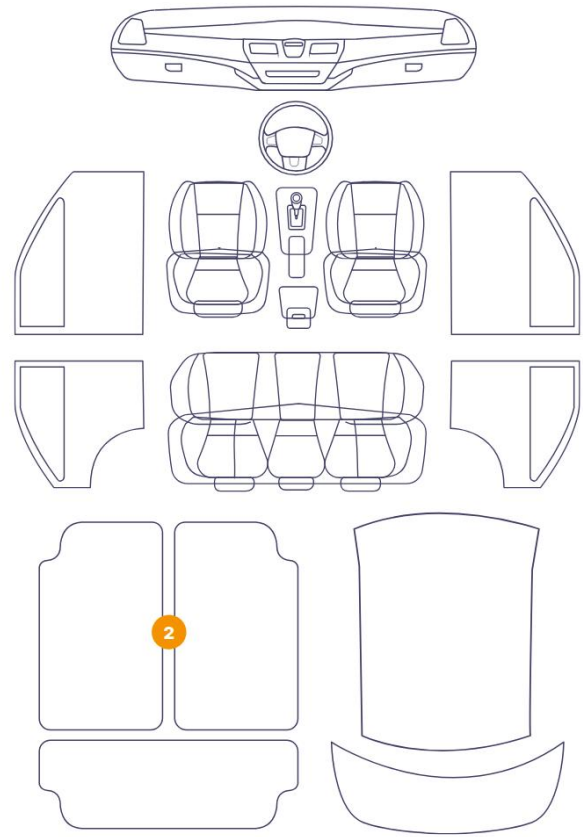
2 Dommages

Component	Damage	Comments
1 Floor Carpet	Interior / Dirty	
2 Floor Carpet	Interior / Dirty	
3 Corner Bumper / Front Right	Paint / Scratch / Scuff	
4 Bumper / Front	Paint / Scratch / Scuff	
5 Corner Bumper / Front Left	Paint / Scratch / Scuff	
6 Rim / Front Left	Out of Bodywork / Scratch	
7 Door / Front Left	Paint / Scratch / Line	
8 Door / Back Left	Paint / Scratch / Line	
9 Rim / Back Left	Out of Bodywork / Scratch	
10 Corner Bumper / Back Left	Paint / Scratch / Scuff	
11 Bumper / Back	Paint / Scratch / Scuff	
12 Corner Bumper / Back Right	Paint / Scratch / Scuff	
13 Rim / Back Right	Out of Bodywork / Scratch

14	Door / Back Right	Paint / Scratch / Line
15	Door / Front Right	Paint / Scratch / Line
16	Door / Front Right	Paint / Scratch / Line
17	Rim / Front Right	Out of Bodywork / Scratch
