## status report

| <b>contract number:</b> | <b>618229170-INSO</b> |

| vehicle data | | | |
|---|---|---|---|
| <b>Citroën Berlingo Kombi Selection</b> | | | |
| Vehicle identification number | <b>VF77JBHY6GJ832162</b> | mileage read: | <b>117178 km</b> |

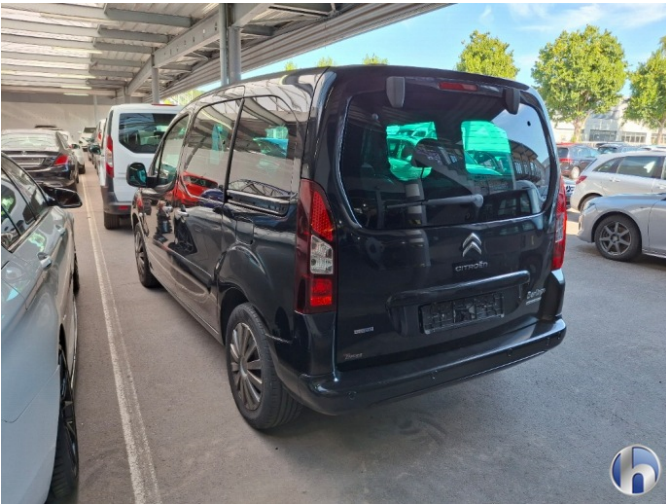
rear Left

| component | Damage | Rep kind |
|---|---|---|
| 8. Sidewall - Rear - Left | Accident damage | Refurbish and paint |
| 9. Rear bumper | Accident damage | Refurbish and paint |
| 11. Taillight left | Accident damage | Replace |

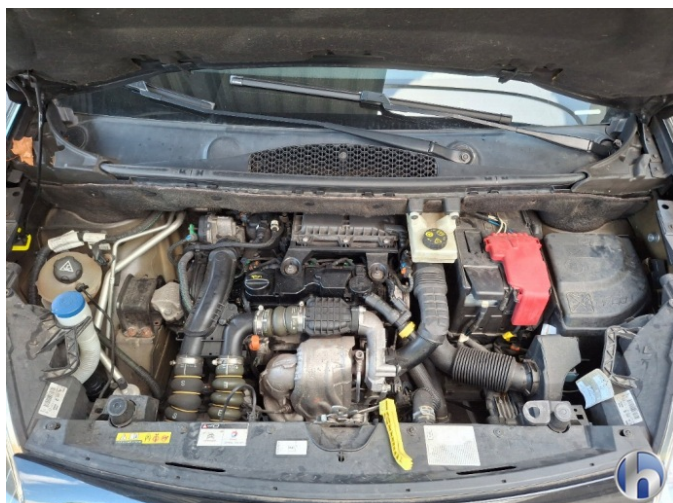
engine compartment

| Performed testing technology | |
|---|---|
| <b>oil loss:</b> | The vehicle was inspected during the visit to an oil leak .<br>**motor. |
