CITROEN C3 C3 Picasso VTi 95 Collection

VIN NO VF7SH8FP0BT526300 Registration Number BQ767LA

Inspection Report Summary

| Customer | BCAuto Encheres | Report Number | P20250930230120 |

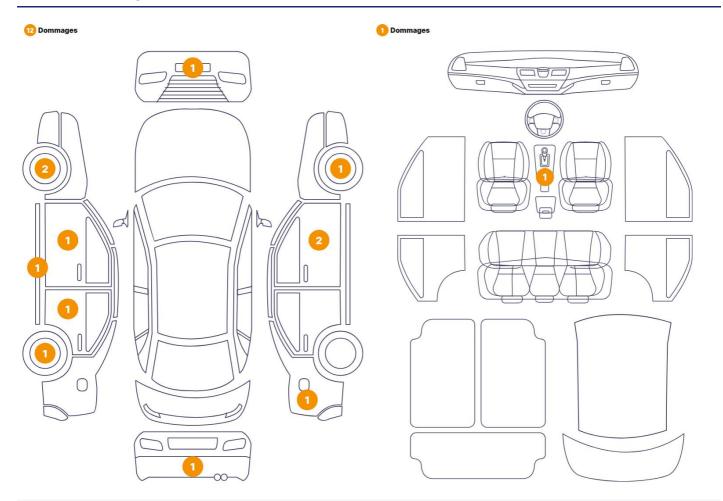
Cosmetic Damage

| | Component | Damage | Comments |
|---|---|---|---|
| 1 | Door / Back Left | Paint / Chipping | |

13 Gear Knob Interior / Broken
