# CITROEN C4

## C4 Picasso HDi 150 FAP Millenium BMP6

VIN NO VF7UDRHB8BJ747173  
Registration Number BT366YJ

### Inspection Report Summary

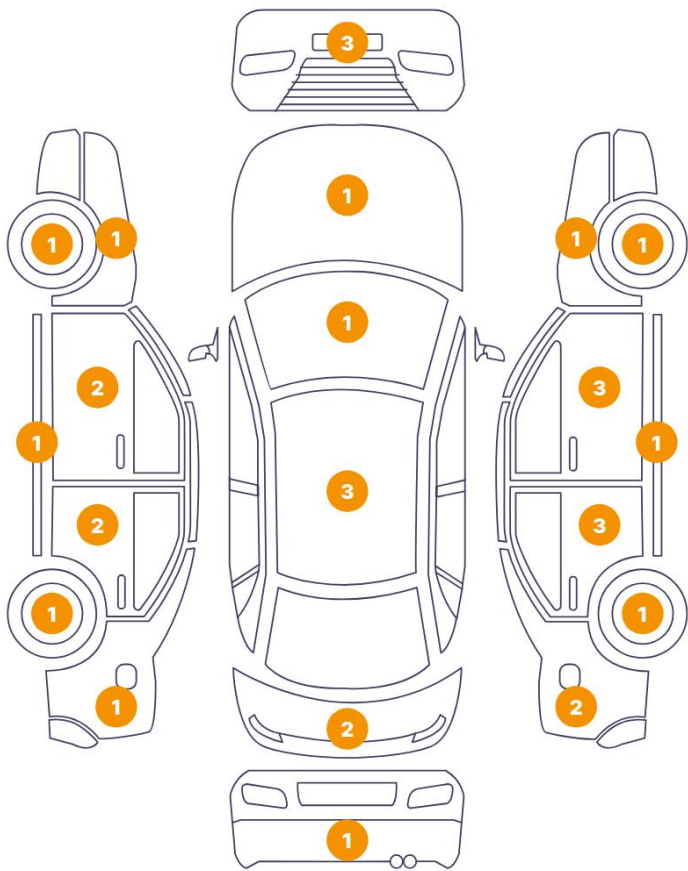
32 Dommages

13	Panel Filling / Front Right	Interior / Scraped
14	Roof	Paint / Poor Previous Repair
15	Cant Rail / Right	Paint / Poor Previous Repair
16	Tailgate	Paint / Poor Previous Repair
17	Tailgate	Bodywork / Dent / Dent
18	Bumper / Back	Paint / Scratch / Line
19	Fender / Back Right	Bodywork / Dent / Deformation
20	Fender / Back Right	Paint / Poor Previous Repair
21	Rim Brake pads	Out of Bodywork / Scratch
22	Door / Back Right	Paint / Poor Previous Repair
23	Door / Back Right	Bodywork / Dent / Dent
24	Door Side Molding / Back Right	Paint / Poor Previous Repair
25	Door / Front Right	Paint / Poor Previous Repair
26	Door / Front Right	Bodywork / Dent / Dent
27	Rocker Panel / Center Right	Paint / Poor Previous Repair
28	Mirror Shell / Front Right	Paint / Scratch / Line
29	Fender / Front Right	Paint / Scratch / Line
30	Rim	Out of Bodywork / Scratch
31	Corner Bumper / Front Right	Paint / Poor Previous Repair
32	Bumper / Front	Paint / Poor Previous Repair

33	Hood	Paint / Poor Previous Repair
34	Corner Bumper / Front Left	Paint / Poor Previous Repair
35	Fender / Front Left	Paint / Scratch / Line
36	Rim	Out of Bodywork / Scratch
37	Pillar / Front Left	Paint / Poor Previous Repair
38	Cant Rail / Left	Paint / Poor Previous Repair
39	Door / Front Left	Paint / Scratch / Line
40	Door / Back Left	Paint / Poor Previous Repair
41	Door / Back Left	Bodywork / Dent / Deformation

42	Rocker Panel / Center Left	Bodywork / Dent / Deformation
43	Rim	Out of Bodywork / Scratch
44	Fender / Back Left	Paint / Scratch / Line
45	Windshield / Front	Glass Break / Impact

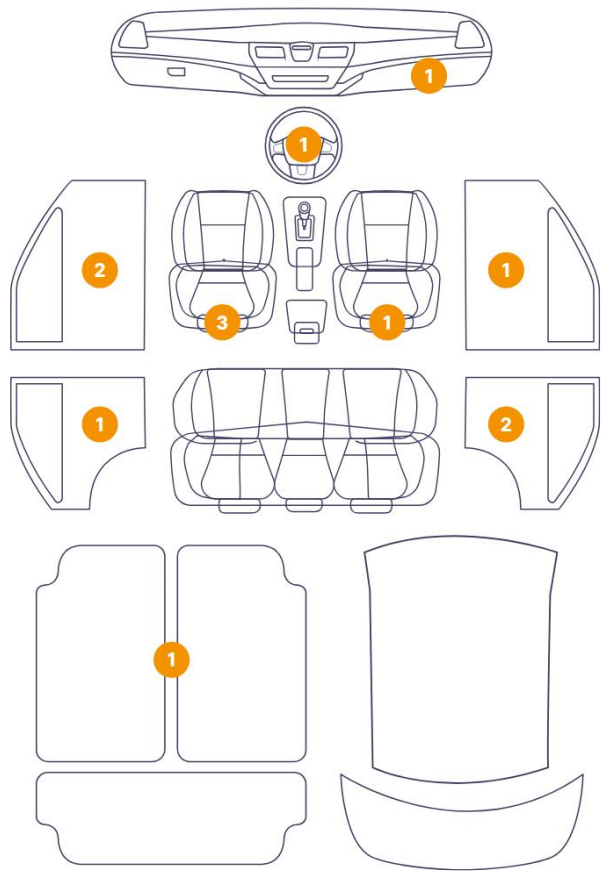
13 Dommages

Component		Damage	Comments
1	Seat / Front Left	Interior / Holed	
2	Seat / Front Left	Interior / Dirty	
3	Floor Carpet	Interior / Ripped	
4	Steering Wheel / Front	Interior / Worn - out	
5	Seat / Front Left	Interior / Broken	
6	Panel Filling / Front Left	Interior / Dirty	
7	Panel Filling / Front Left	Interior / Scraped	
8	Panel Filling / Back Left	Interior / Scraped	
9	Panel Filling / Back Right	Interior / Scraped	
10	Panel Filling / Back Right	Interior / Stained	
11	Seat / Front Right	Interior / Broken	
12	Glovebox	Interior / Scraped
