# CITROEN JUMPER (30) JUMPER TOLE 4-35 L4H2 BLUEHDi 165 S&S BVM6 CLUB

VIN NO VF7YDCNFC12S28938  
Registration Number FX418XG

## Inspection Report Summary

Customer	BCAauto Encheres	Report Number	P20250808102944
Inspection Date / Place	2025-08-08 / BCA ANGOULEME	Cosmetic Grade	9

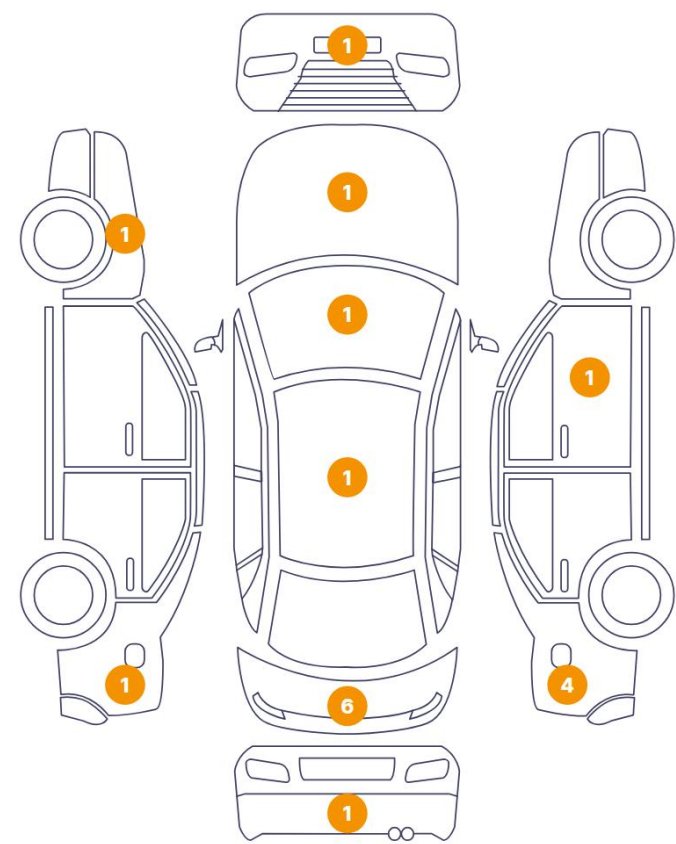
18 Dommages

Component		Damage	Comments
1	Panel Filling / Front Left	Interior / Dirty	
2	Floor Carpet	Interior / Dirty	
3	Seat Cushion / Front Left	Interior / Dirty	
4	Seat Cushion / Front Left	Interior / Holed	
5	Window Switch / Front Right	Interior / Missing	
6	Hood	Missing Part	
7	Shield / Front	Missing Part	
8	Fender / Front Left	Bodywork / Dent / Deformation	
9	Windshield / Front	Glass Break	
10	Side Panel / Back Left	Bodywork / Dent / Deformation	
11	Corner Bumper / Back Left	Bodywork / Dent / Deformation	
12	Swing Door / Back Left	Bodywork / Dent / Dent	
13	Swing Door / Back Left	Bodywork / Dent / Dent
