Expertise

Protocol number: 41265400
Order No. / Reference: 25092023
Inspection date: 28 Aug 2025

Manufacturer: Peugeot

Model: 2008 Elektro GT

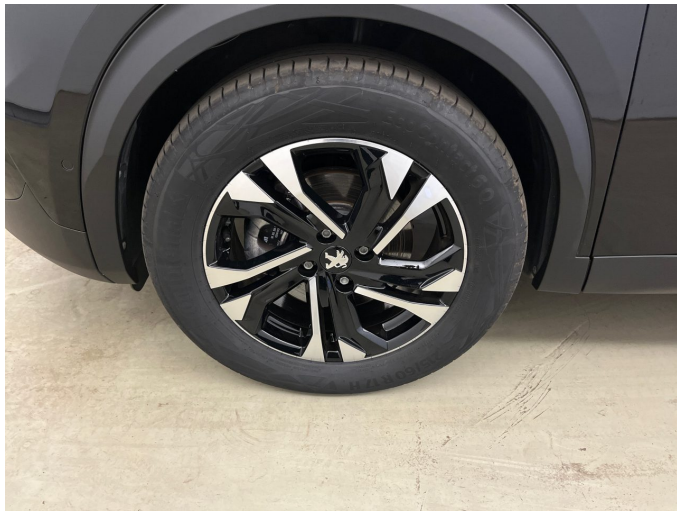
Figure 13: Mounted tyres

#	Tyre size	Type of tyre	Manufacturer	Tread depth
1)	215/60 R17 96H	Summer tyres on Light alloy	Continental	6mm / 6mm
2)	215/60 R17 96H	Summer tyres on Light alloy	Continental	6mm / 6mm

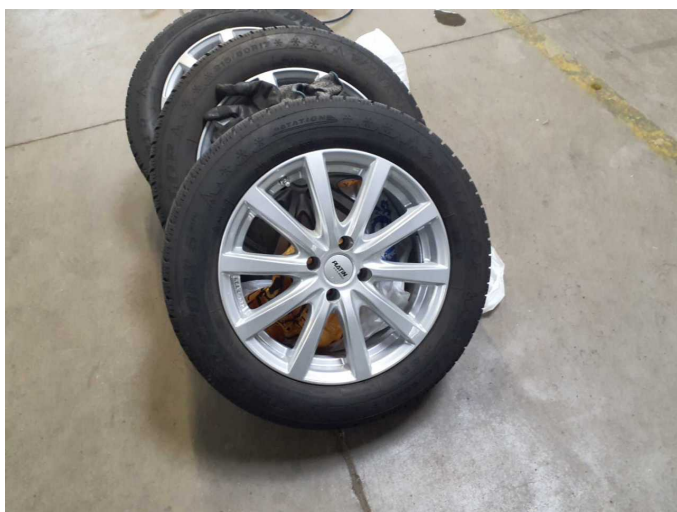
Figure 17: Additional tyres

#	Tyre size	Type of tyre	Manufacturer	Tread depth
1)	215/60 R17 100V	Winter tyres on Light alloy	Dunlop	6mm / 6mm
2)	215/60 R17 100V	Winter tyres on Light alloy	Dunlop	6mm / 6mm
