# PEUGEOT 208

## 208 Hybrid 100 e-DCS6 Allure

VIN NO VR3UPHPX5S4051647  
Registration Number HC552BM

### Inspection Report Summary

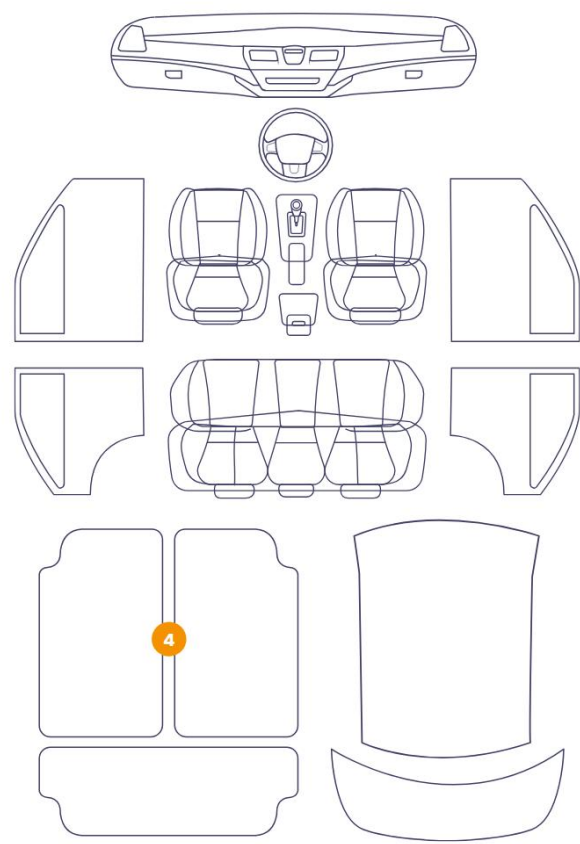
4 Dommages

| Component | | Damage | Comments |
|---|---|---|---|
| 1 | Floor Carpet | Interior / Missing | |
| 2 | Floor Carpet | Interior / Missing | |
| 3 | Floor Carpet | Interior / Missing | |
| 4 | Floor Carpet | Interior / Missing | |
