## status report

| vehicle data | | | |
|---|---|---|---|
| <b>Cupra Ateca Basis</b> | | | |
| Vehicle identification number | <b>VSSZZZ5F6R6522462</b> | mileage read: | <b>18908 km</b> |

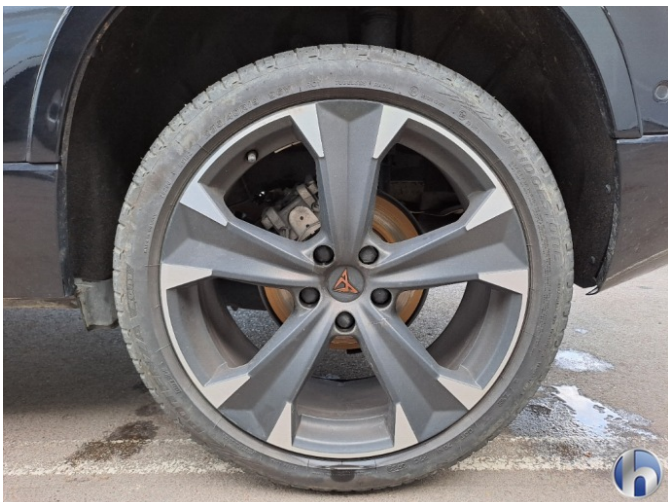
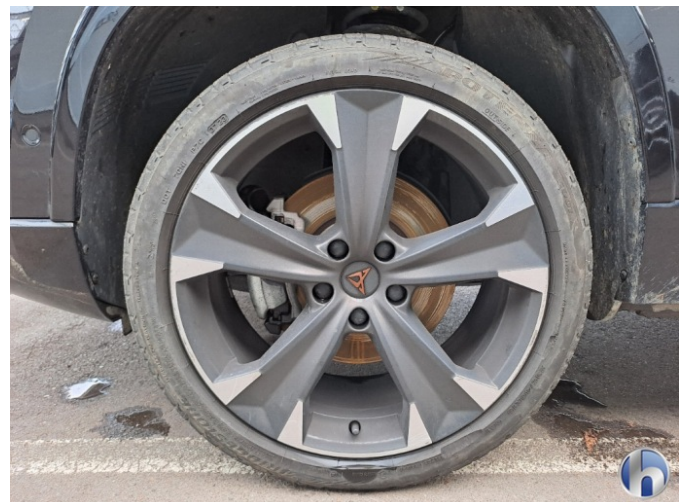
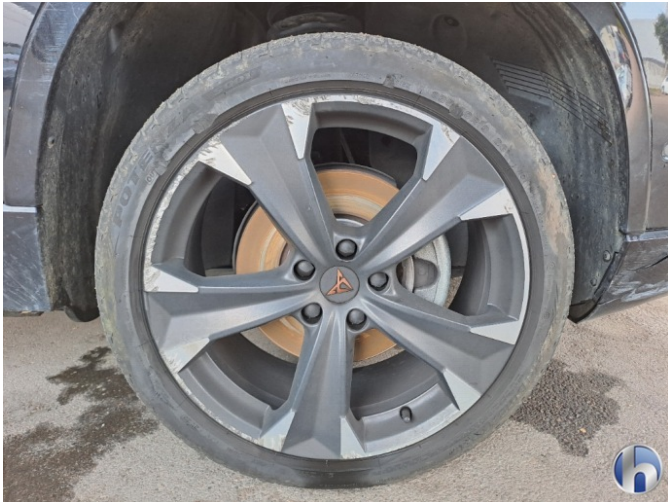
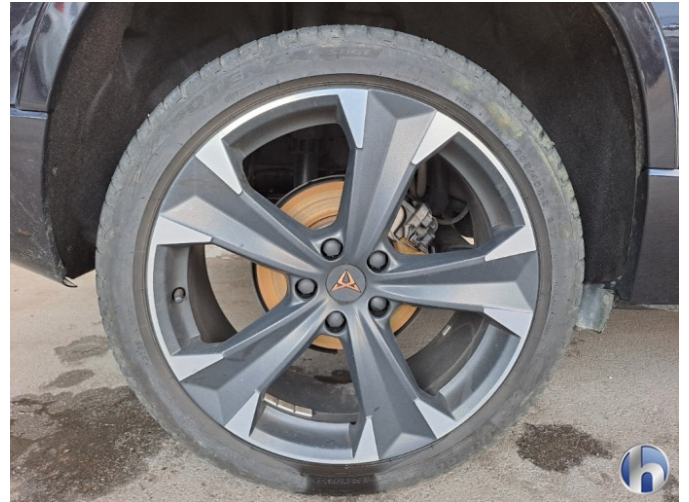
rims

| <b>Note Road Safe:</b> | Vordere Bereifung beschädigt. |

| | component | Damage | Rep kind |
|---|---|---|---|
| 1. | Rim front - right | Damaged | Replace |
| 2. | tire front - right | Damaged | Replace |
| 8. | Rim front - left | Damaged | Replace |
| 9. | tire front - left | Damaged | Replace |

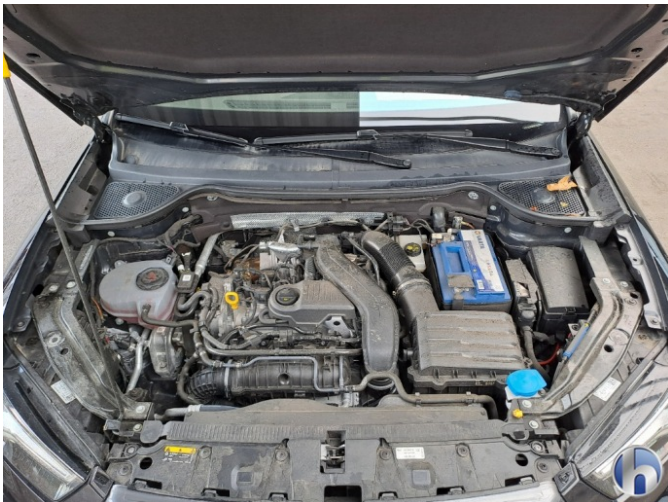
engine compartment

| Performed testing technology | |
|---|---|
| <b>oil loss:</b> | The vehicle could be checked only limited to oil leaks . |
| <b>engine running:</b> | Checking the engine running was limited. Here no audible or visual abnormalities were noted . |
