Expertise

Protocol number: 41419630
Order No. / Reference: 25196922
Inspection date: 9 Sept 2025

Manufacturer: Opel	Model: Vivaro 1.5 D Cargo M Edition
VIN: VXEVBYHVKM7829536

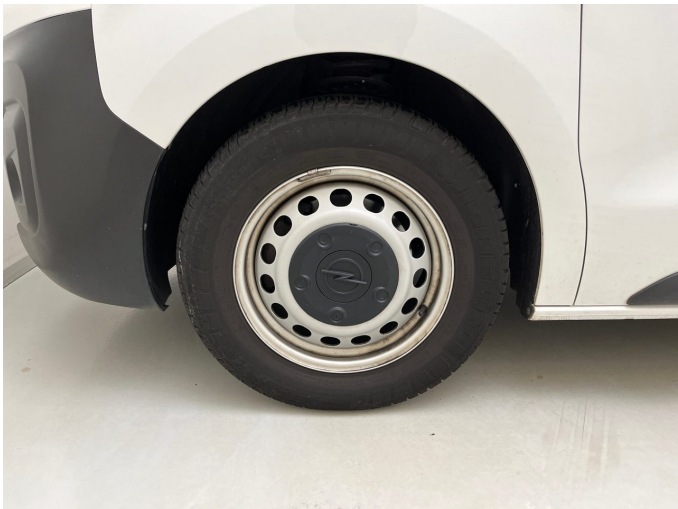
Figure 12: Mounted tyres

#	Tyre size	Type of tyre	Manufacturer	Tread depth
1)	215/65 R16 106T	Summer tyres on Steel rim with wheel cover	Michelin	5mm / 4mm
2)	215/65 R16 106T	Summer tyres on Steel rim with wheel cover	Michelin	7mm / 7mm

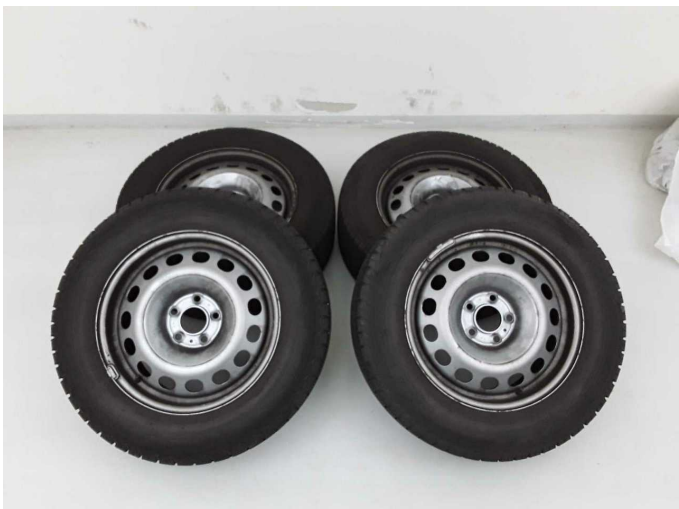
Figure 18: Additional tyres

#	Tyre size	Type of tyre	Manufacturer	Tread depth
1)	215/65 R16 106T	Winter tyres on Steel	Bridgestone	8mm / 8mm
2)	215/65 R16 106T	Winter tyres on Steel	Continental	9mm / 9mm
