Expertise

Protocol number: 41516936
Order No. / Reference: 25212786
Inspection date: 15 Sept 2025

Model: Vivaro 2.0 D Cargo L EHZ Edition

VIN: VXEVFAHXKMZ038240

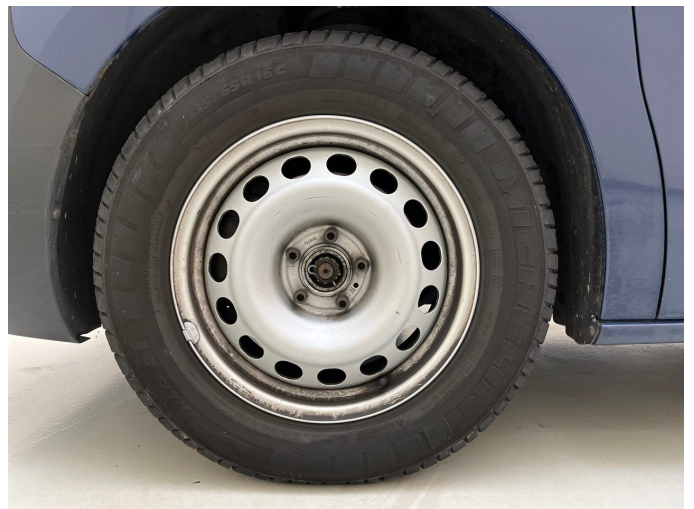
Figure 12: Mounted tyres

#	Tyre size	Type of tyre	Manufacturer	Tread depth
1)	215/65 R16 106T	Summer tyres on Steel rim with wheel cover	Michelin	7mm / 7mm
2)	215/65 R16 106T	Summer tyres on Steel rim with wheel cover	Michelin	6mm / 6mm

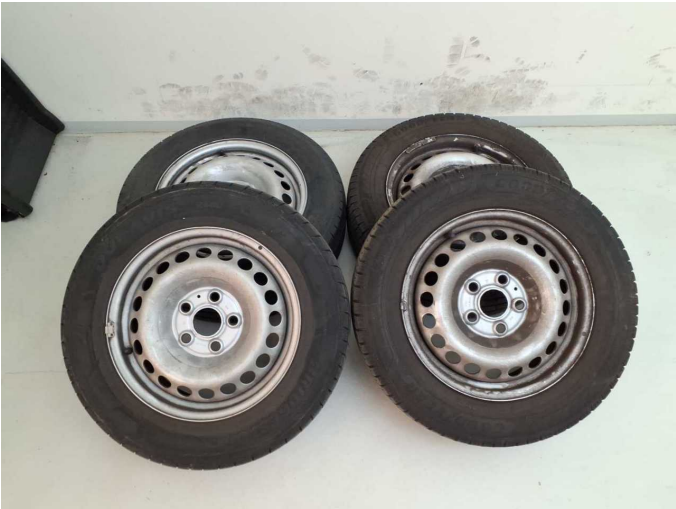
Figure 17: Additional tyres

Typ	Tyre size	Type of tyre	Manufacturer	Tread depth
E	215/65 R16 106T C	Summer tyres on Steel	Michelin	9 mm
