## status report

#### Opel Movano C Kasten GKa L4H3 3,5t Edition

| Vehicle identification number | <b>VXEYDCPFCNG008841</b> | mileage read: | <b>87587 km</b> |

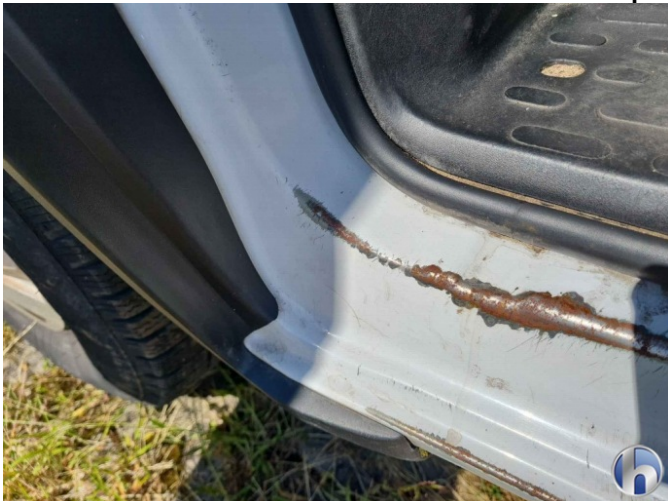
3. Türeinstieg Vorne - Links

**Scrape**

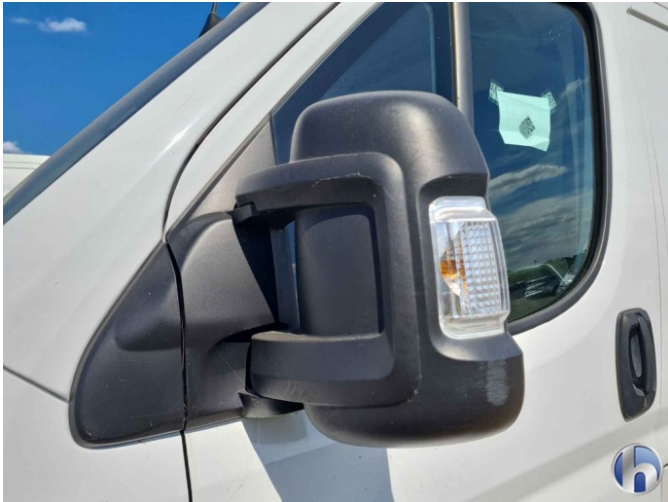
| | component | Damage | Rep kind |
|---|---|---|---|
| 11. | Outside mirror - left | Scrape | Replace |

11. Outside mirror - left

**Scrape**

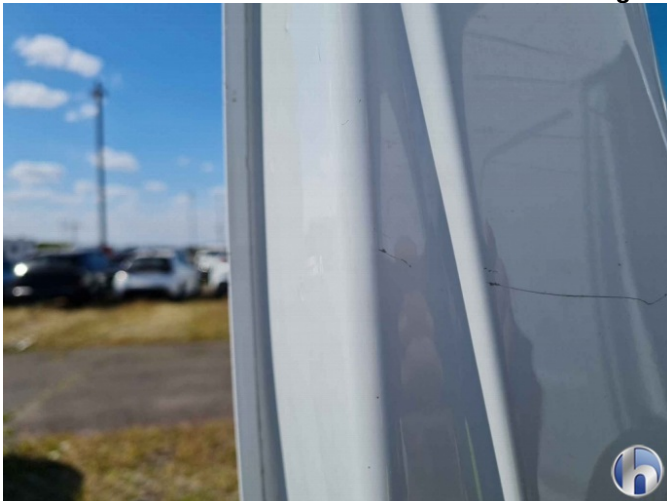
| | component | Damage | Rep kind |
|---|---|---|---|
| 14. | Tür Vorne - Links - Innen | Scratch(es) | Smart repair |

14. Tür Vorne - Links - Innen

**Scratch(es)**

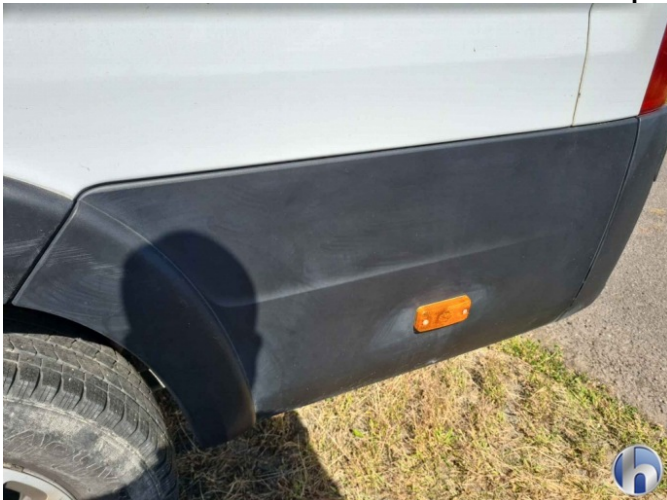
| | component | Damage | Rep kind |
|---|---|---|---|
| 16. | Radlaufleiste hinten<br>Seitenwandverkleidung links außen | Scrape | Replace |

16. Radlaufleiste hinten Seitenwandverkleidung links außen

Scrape

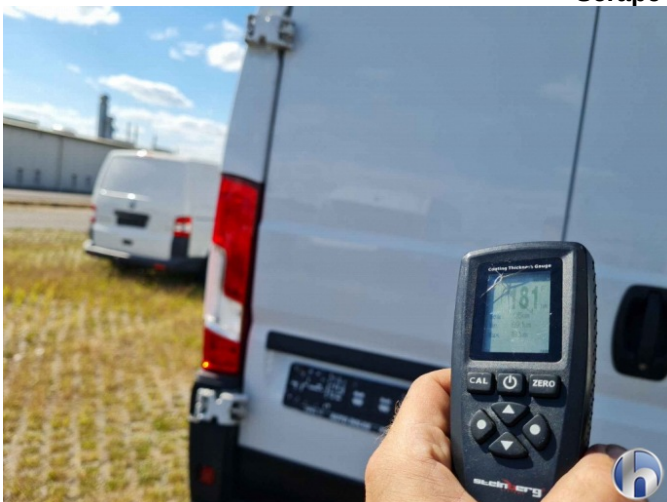
17. Tailgate left

Subsequently painted
