Expertise

Protocol number: 41295093
Order No. / Reference: 25080565
Inspection date: 29 Aug 2025

Manufacturer: Opel

Model: Astra Sports Tourer 1.5 D GS Line

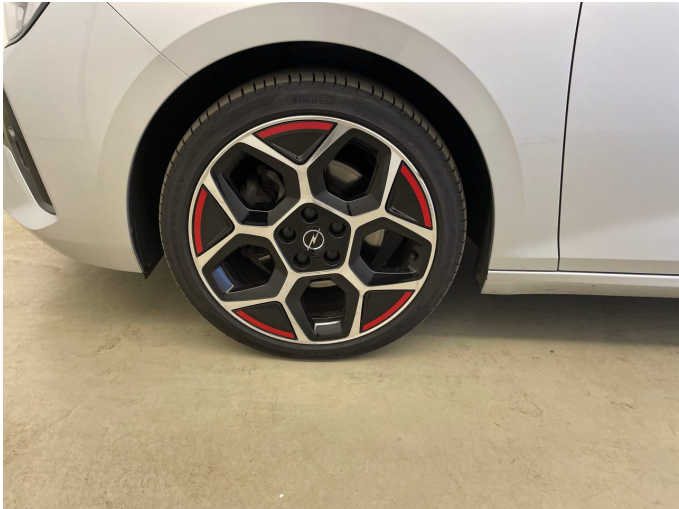
Figure 12: Mounted tyres

#	Tyre size	Type of tyre	Manufacturer	Tread depth
1)	225/40 R18 92Y	Summer tyres on Light alloy	Pirelli	5mm / 5mm
2)	225/40 R18 92Y	Summer tyres on Light alloy	Pirelli	5mm / 5mm
