## status report

| vehicle data | | | |
|---|---|---|---|
| <b>Opel Astra L Sports Tourer Basis</b> | | | |
| Vehicle identification number | <b>VXKFRHNSTP1042461</b> | mileage read: | <b>45452 km</b> |

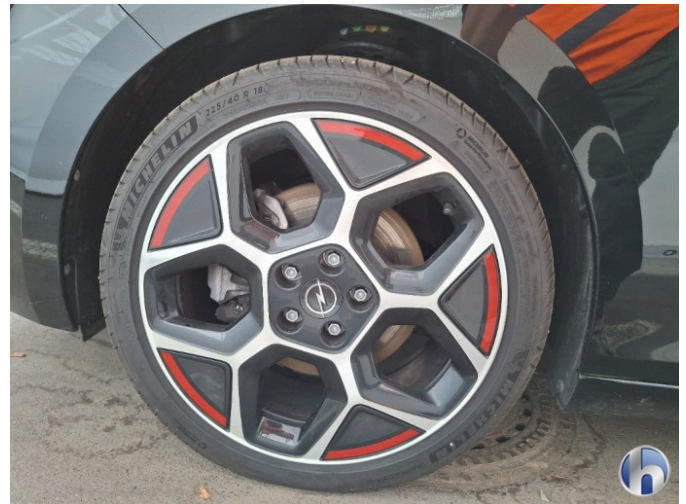
rims

| | component | Damage | Rep kind |
|---|---|---|---|
| 2. | Rim front - right | Damaged | Replace |
| 3. | Rim front - left | Damaged | Replace |
