## status report

#### Opel Corsa F Elegance

| Vehicle identification number | <b>VXKUPHNKKL4023805</b> | mileage read: | <b>122641 km</b> |

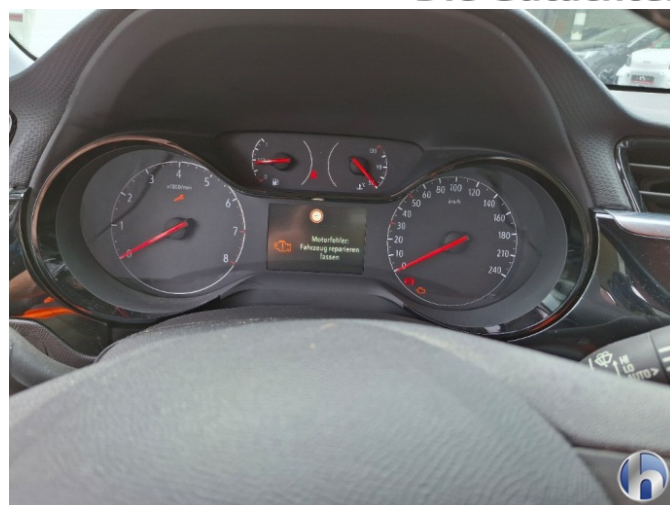
instrument cluster

| Performed testing technology | |
|---|---|
| <b>engine running:</b> | A field test of the engine had to acoustic or visual defects for visiting time .<br>**Engine warning light. |

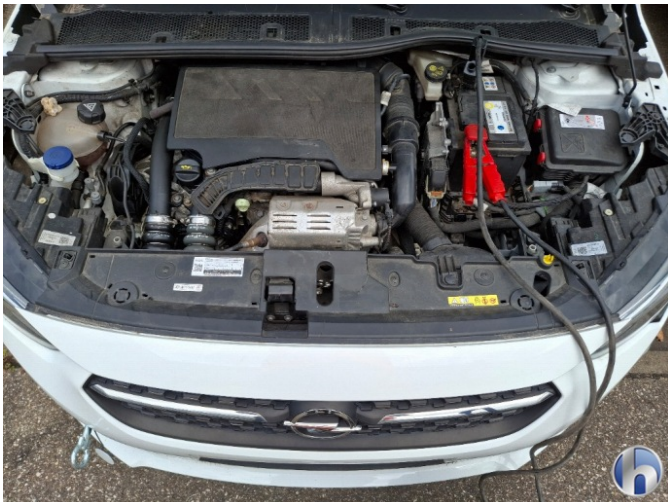
engine compartment

| Performed testing technology | |
|---|---|
| <b>oil loss:</b> | The vehicle was inspected during the visit to an oil leak .<br>*Antriebsriemen für Lichtmaschine abgesprungen<br>**motor. |
