OPEL Corsa Corsa 1.3 CDTI DPF ecoFLEX Start-Stop

VIN NO W0L0SDL68D4039889 Registration Number 68D4039889

Inspection Report Summary

Customer	BCA Online	Report Number	P20250919105938
Inspection Date / Place	2025-09-19 / ARS Altmann AG Riedstadt	Cosmetic Grade	4

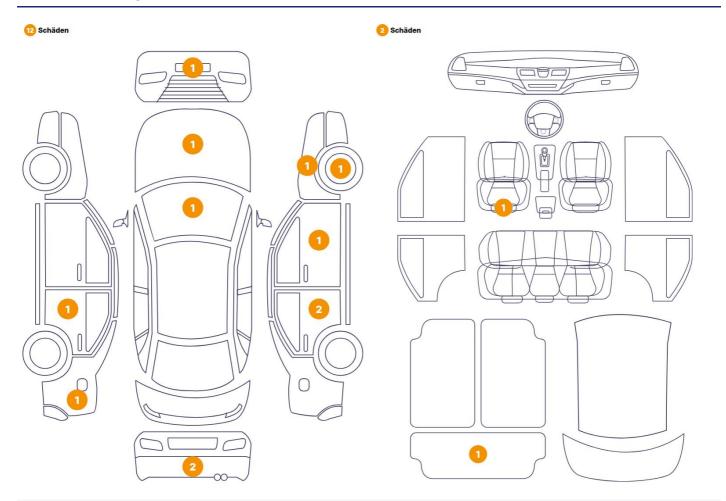
Cosmetic Damage

Component	Damage	Comments
1	Hood	Bodywork / Dent / Dent	
2	Bumper / Front	Paint / Scratch / Scuff	
3	Seat / Front Left	Interior / Ripped	
4	Door / Back Left	Paint / Scratch / Scuff	
5	Side Panel / Back Left	Paint / Scratch / Scuff	
6	Bumper / Back	Paint / Scratch / Scuff	
7	Bumper / Back	Paint / Scratch / Scuff	
8	Luggage Space Cover / Back	Interior / Missing	
9	Door / Back Right	Paint / Scratch / Scuff	
10	Pillar / Back Right	Paint / Scratch / Scuff	
11	Door / Front Right	Bodywork / Dent / Deformation	
12	Fender / Front Right	Bodywork / Dent / Deformation

To Mill / Front Might Out of Body Work / Octation	13	Rim / Front Right	Out of Bodywork /	/ Scratch
---	----	-------------------	-------------------	-----------

14 Windshield / Front Glass Break / Impact
