## OPEL Astra

### Astra 1.6 Caravan

### Inspection Report Summary

| Customer | BCA Online | Report Number | P20250716122707 |

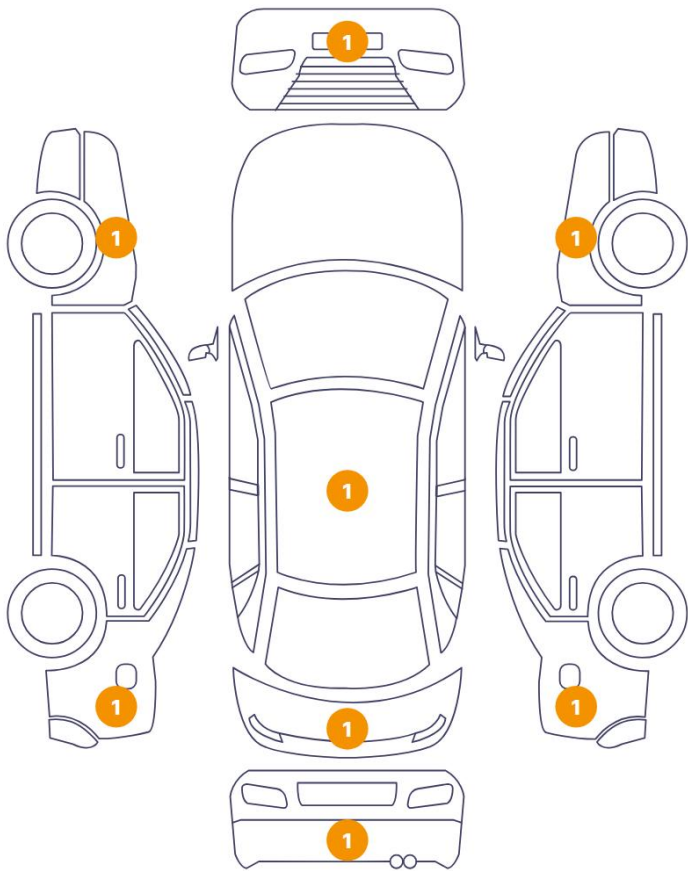
8 Schäden

| Component | | Damage | Comments |
|---|---|---|---|
| 1 | Bumper / Front | Paint / Scratch / Scuff | |
| 2 | Fender / Front Left | Paint / Corrosion | |
| 4 | Side Panel / Back Left | Paint / Corrosion | |
| 7 | Tailgate | Paint / Corrosion | |
| 8 | Side Panel / Back Right | Paint / Corrosion | |

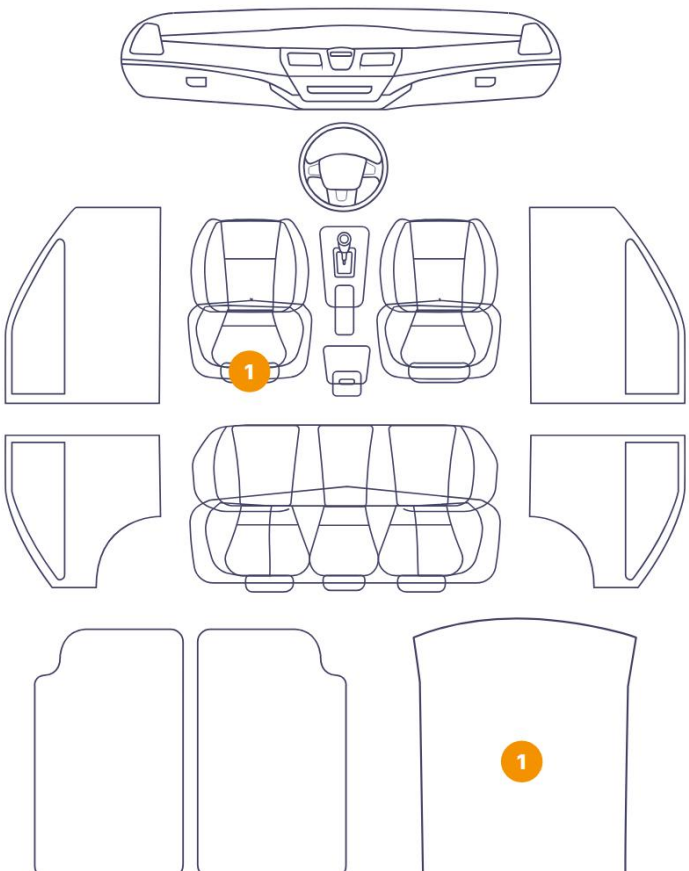
2 Schäden

| Component | | Damage | Comments |
|---|---|---|---|
| 10 | Roof Upholstery | Interior / Loose | |
