OPEL CORSA

Corsa 1.3 CDTI Cosmo

VIN NO W0L0XCF6844286320
Registration Number DA385XT

Customer	BCAuto Encheres	Report Number	P20250811100343
Inspection Date / Place	2025-08-11 / BCA GARONS	Cosmetic Grade	5

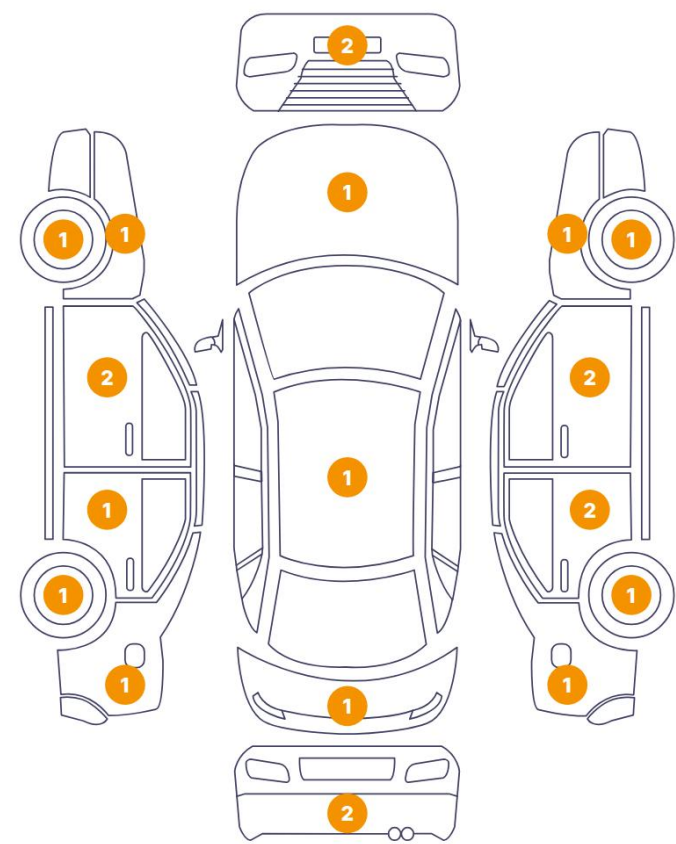
22 Dommages

Component		Damage	Comments
1	Hood	Paint / Poor Previous Repair	
2	Bumper / Front	Bodywork / Breakage / Crack	
3	Rim / Front Left	Out of Bodywork / Scratch	
4	Wing Stick / Front Left	Missing Part	
5	Mirror / Front Left	Paint / Scratch / Line	
6	Door / Front Left	Bodywork / Dent / Deformation	
7	Door / Back Left	Bodywork / Dent / Deformation	
8	Rim / Back Left	Out of Bodywork / Scratch	
9	Fender / Back Left	Bodywork / Dent / Deformation	
10	Roof	Paint / Poor Previous Repair	
11	Steering Wheel / Front	Interior / Worn - out	
12	Floor Carpet	Interior / Ripped	
13	Seat / Front Left	Interior / Burn

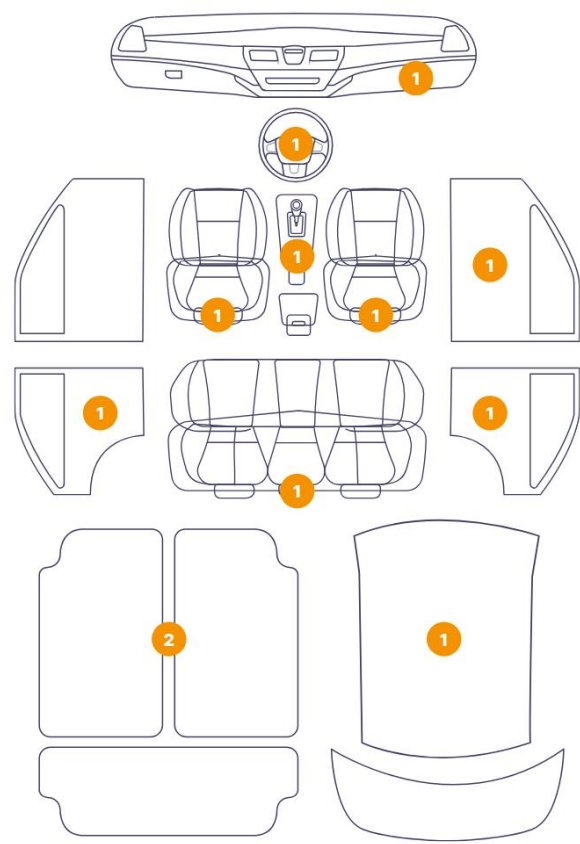
12 Dommages

14	Roof Upholstery	Interior / Stained
15	Gear Knob	Interior / Ripped
16	TV DVD Screen / Front	Interior / Missing
17	Panel Filling / Back Left	Interior / Broken
18	Seat / Back Center	Interior / Stained
19	Bumper / Back	Bodywork / Dent / Deformation
20	Tailgate	Bodywork / Dent / Deformation
21	Bumper / Back	Bodywork / Dent / Deformation
22	Rim / Back Right	Out of Bodywork / Scratch
23	Fender / Back Right	Bodywork / Dent / Deformation
24	Door / Back Right	Bodywork / Dent / Deformation
25	Door / Back Right	Paint / Scratch / Line
26	Panel Filling / Back Right	Interior / Broken
27	Door / Front Right	Bodywork / Dent / Deformation
28	Mirror / Front Right	Paint / Scratch / Line
29	Seat / Front Right	Interior / Stained
30	Floor Carpet	Interior / Stained
31	Panel Filling / Front Right	Interior / Broken
32	Fender / Front Right	Bodywork / Dent / Deformation
33	Rim / Front Right	Out of Bodywork / Scratch
34	Bumper / Front	Paint / Scratch / Line
