OPEL CORSA

Corsa 1.4 90 ch Edition

VIN NO W0L0XEP68G4115474
Registration Number DZ832BG

Inspection Report Summary

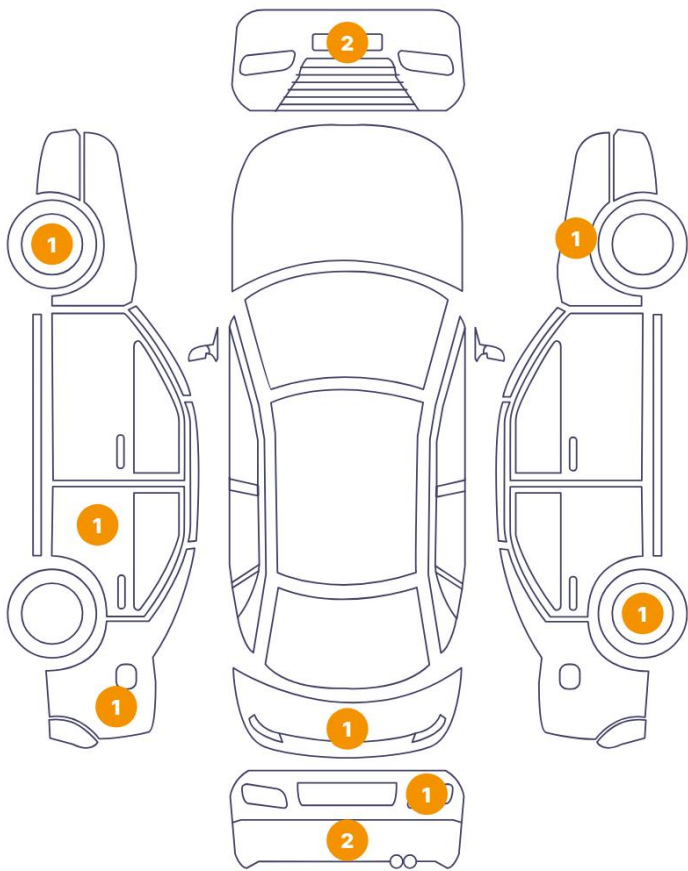
11 Dommages

| Component | | Damage | Comments |
|---|---|---|---|
| 1 | Shield / Front | Paint / Scratch / Line | |

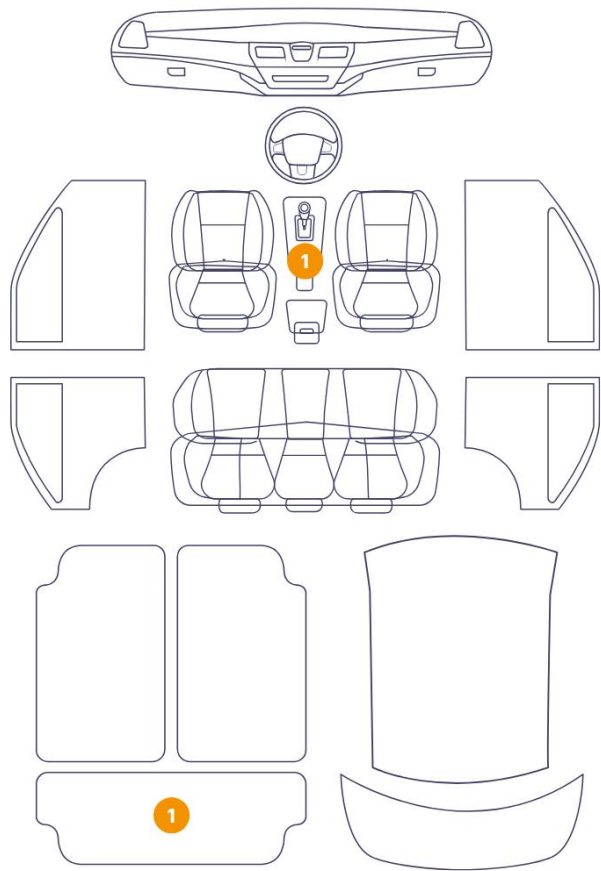
2 Dommages

| Component | | Damage | Comments |
|---|---|---|---|
| 5 | Luggage Space Cover / Back | Interior / Broken | |

5. Luggage Space Cover / Back
Interior / Broken -
