## OPEL Corsa Corsa 1.2

VIN NO W0L0XEP68G4131657

### Inspection Report Summary

| Customer | BCA Online | Report Number | P20250822123359 |

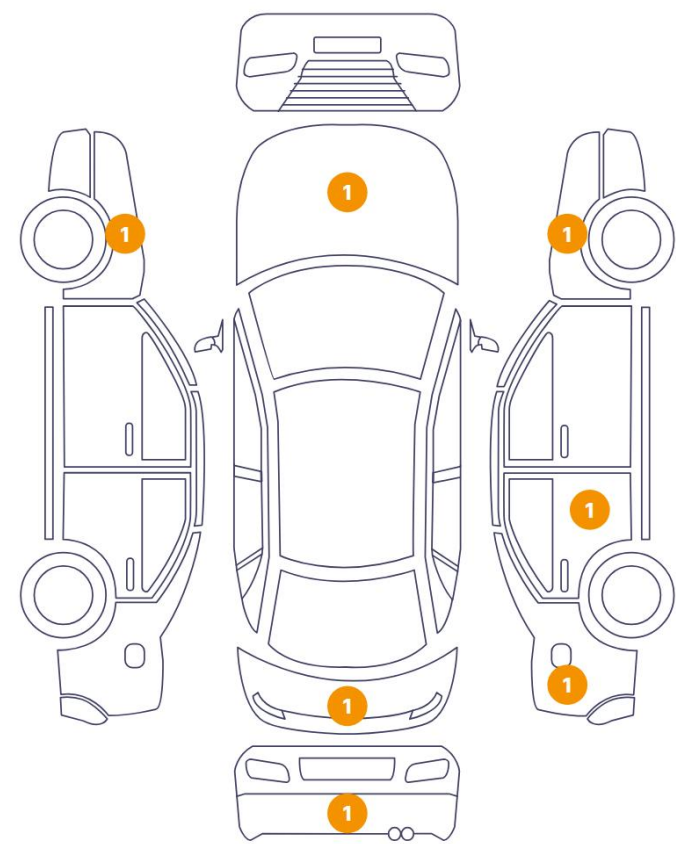
7 Schäden

| Component | | Damage | Comments |
|---|---|---|---|
| 1 | Bumper / Back | Paint / Scratch / Scuff | |

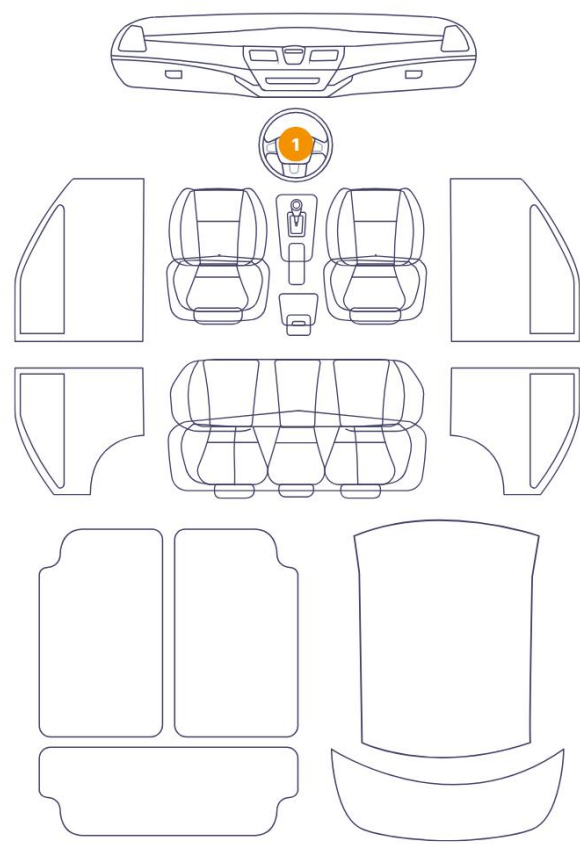
1 Schäden

| Component | | Damage | Comments |
|---|---|---|---|
| 8 | Steering Wheel / Front | Interior / Worn - out | |

8. Steering Wheel / Front  
Interior / Worn - out -
