## status report

**customer:** BCA Autoauktionen GmbH  
**contract number:** 4002799981  
**reference:**

#### Opel Insignia A Sports Tourer Innovation

| Vehicle identification number | <b>W0LGT8E10G1073166</b> | mileage read: | <b>156321 km</b> |

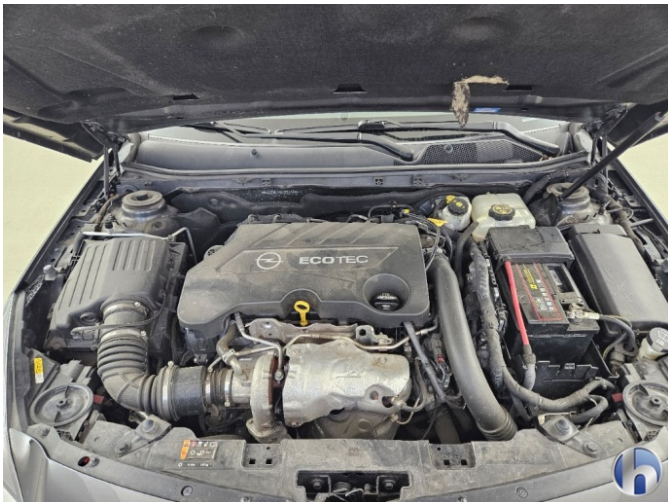
engine compartment

| component | Damage | Rep kind |
|---|---|---|
| 6. motor insulation | Damaged | Replace |
