OPEL Astra Astra 1.3 CDTI DPF ecoFLEX Sports TourerStart/Stop

VIN NO W0LPD8EA5C8017786
Registration Number A5C8017786

Inspection Report Summary

Customer	BCA Online	Report Number	P20250903105854
Inspection Date / Place	2025-09-03 / Dello Bremen	Cosmetic Grade	5

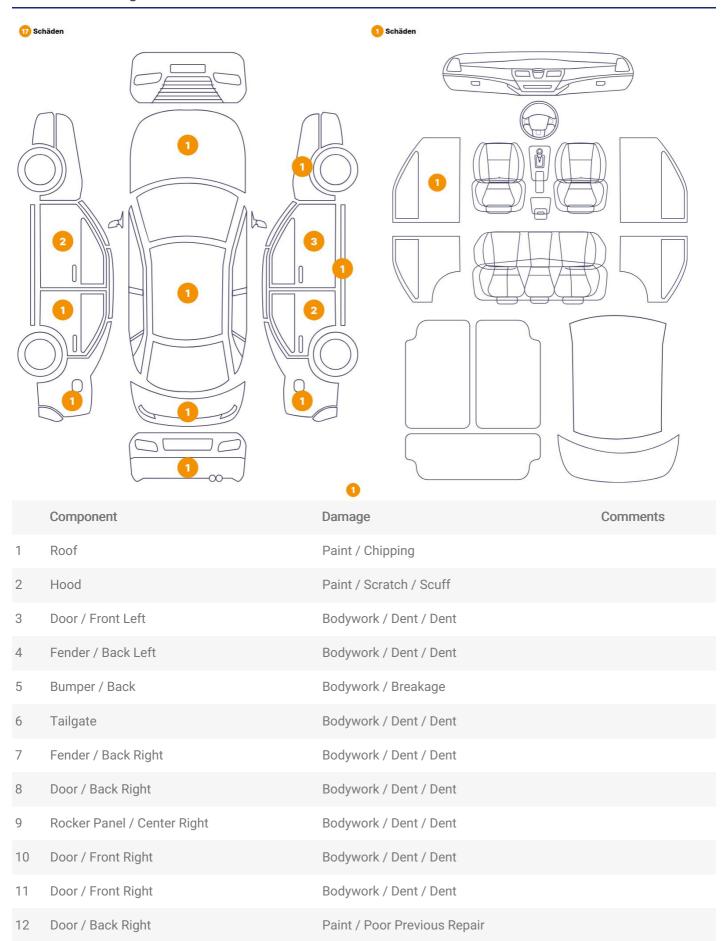
Cosmetic Damage

13	Door / Front Right	Paint / Poor Previous Repair
14	Fender / Front Right	Bodywork / Dent / Dent
15	Door / Back Left	Paint / Poor Previous Repair
16	Door / Front Left	Paint / Poor Previous Repair
17	Panel Filling / Front Left	Interior / Worn - out
18	Other	Bodywork / Dent / Dent
