# OPEL Zafira

## Zafira Tourer 1.4 Turbo

VIN NO W0LPD9EC4G1117352  
Registration Number C4G1117352

### Inspection Report Summary

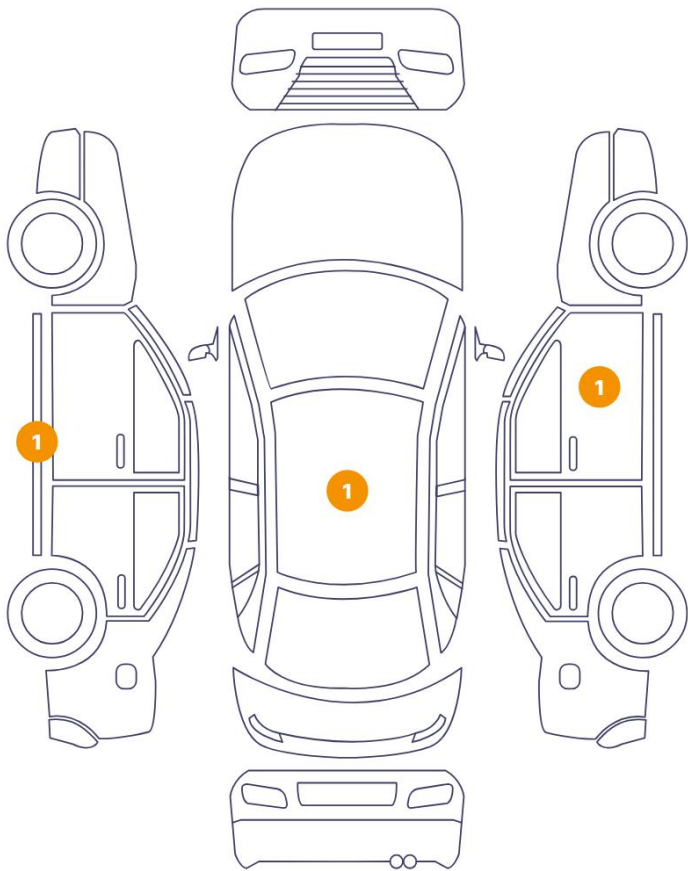
3 Schäden

| Component | Damage | Comments |
|---|---|---|
| 1 Roof | Bodywork / Dent / Dent | |
| 3 Luggage Space Cover / Back | Interior / Missing | |

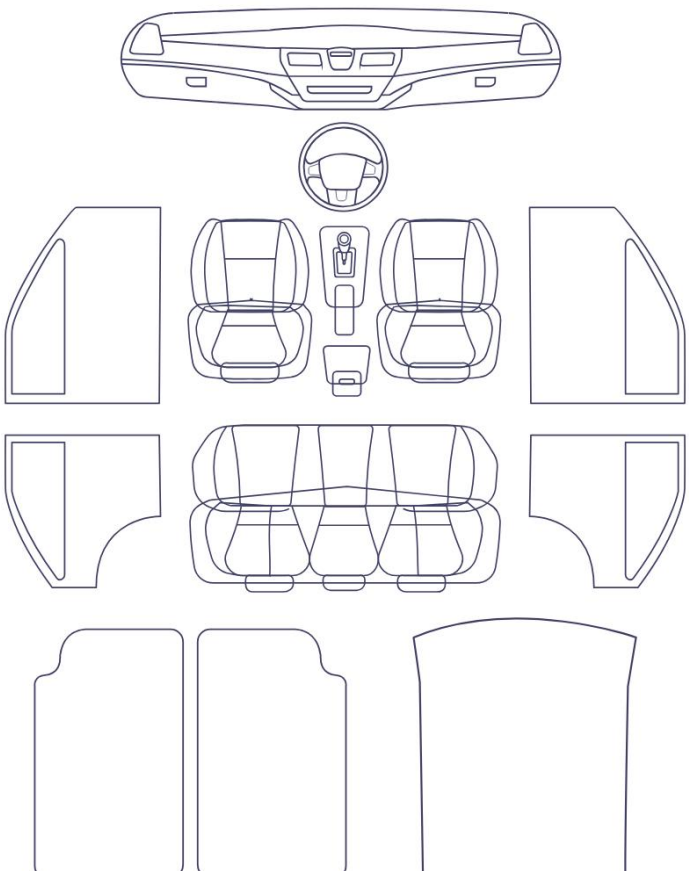
1 Schäden

3. Luggage Space Cover / Back  
Interior / Missing -
