Expertise

Protocol number: 41479586
Order No. / Reference: 25171988
Inspection date: 11 Sept 2025

Manufacturer: Opel	Model: Crossland 1.5 Diesel Elegance
VIN: W0V7H9ENXP4013105

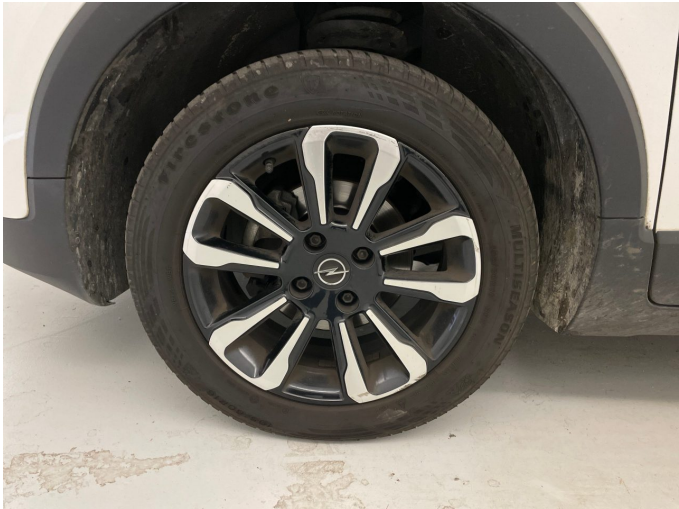
Figure 12: Mounted tyres

#	Tyre size	Type of tyre	Manufacturer	Tread depth
1)	195/60 R16 89H	All-season tyres on Light alloy	Firestone	2mm / 2mm
2)	195/60 R16 93V	All-season tyres on Light alloy	Bridgestone	6mm / 6mm
