Expertise

Protocol number: 41518349
Order No. / Reference: 25228164
Inspection date: 15 Sept 2025

Manufacturer: Opel

Model: Astra 1.5 D Start/Stop Sports Tourer Edition

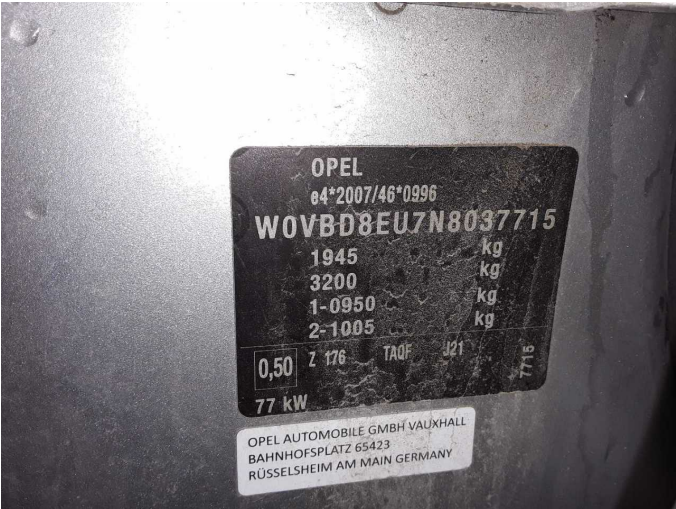
Figure 11: VIN

Documents submitted	At the time of the inspection, the registration certificate Part 2 (letter) was available, but the registration certificate Part 1 (certificate) was not. (Copy)
VIN comparison	The vehicle identification number (VIN) was read from the vehicle and its conformity with the submitted documents was verified during the inspection by the undersigned.
Inspection	The inspection conditions were sufficient for the assessment of the vehicle. Lifting equipment and a pit were available for examining the vehicle.
Test drive	No test drive/maneuvering was carried out during the inspection of the vehicle.
Engine function test	An engine test run was performed.
Driving readiness	The vehicle was drivable at the time of inspection.

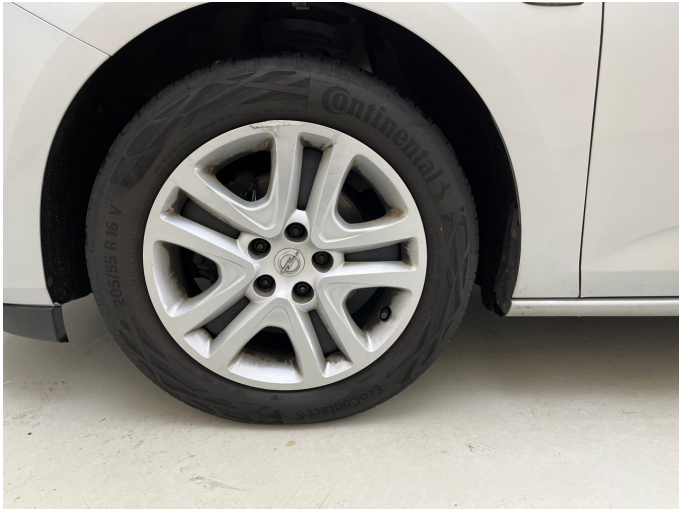
Figure 12: Mounted tyres

#	Tyre size	Type of tyre	Manufacturer	Tread depth
1)	205/55 R16 91V	Summer tyres on Steel rim with wheel cover	Continental	4mm / 4mm
2)	205/55 R16 91V	Summer tyres on Steel rim with wheel cover	Continental	5mm / 5mm

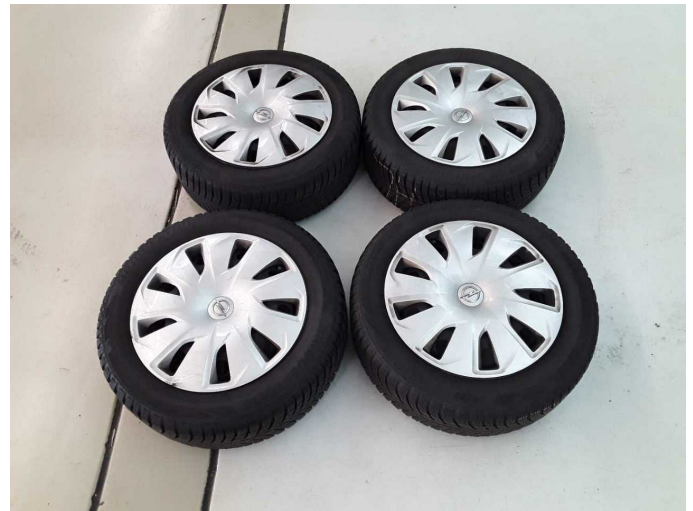
Figure 16: Additional tyres

#	Tyre size	Type of tyre	Manufacturer	Tread depth
1)	205/55 R16 91H	Winter tyres on Steel rim with wheel cover	Bridgestone	4mm / 4mm
2)	205/55 R16 91H	Winter tyres on Steel rim with wheel cover	Bridgestone	6mm / 6mm
