Expertise

Protocol number: 41861043  
Order number / reference: 25287105  
Inspection date: 2 Oct 2025

| Manufacturer: Opel | Model: Astra 1.5 D Start/Stop Sports Tourer Edition |

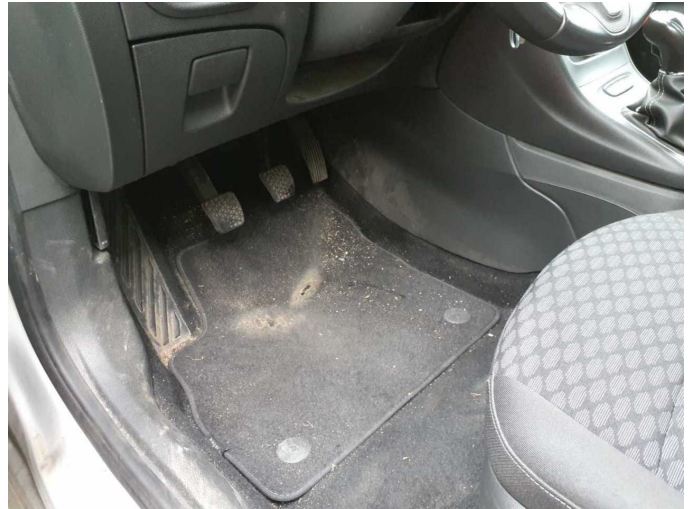
**Damage 1:** Trim / covers: Floor mats - Holes - Replace
