Expertise

Protocol number: 41500800  
Order No. / Reference: 25129875  
Inspection date: 12 Sept 2025

Manufacturer: Opel	Model: Astra 1.5 D Start/Stop Sports Tourer Automatik Business Edition
VIN: W0VBD8EV9N8043041

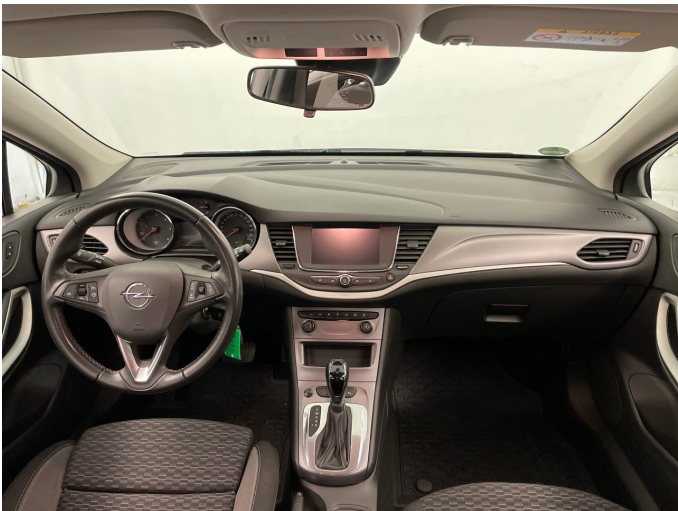
Figure 8: Instrument panel

No.	Component group	Description
1	Instrument panel	Indicator light (Reifendruck) - on - Perform diagnosis
2	Bonnet	Bonnet - dent(s) - Smart repair
3	Engine	Engine (Ruckelt) - Functional / admissibility - Perform diagnosis
