OPEL Astra Astra 1.5 D Start/Stop Sports Tourer

VIN NO W0VBE8EU2L8039107 Registration Number U2L8039107

Inspection Report Summary

| Customer | BCA Online | Report Number | P20250924155838 |

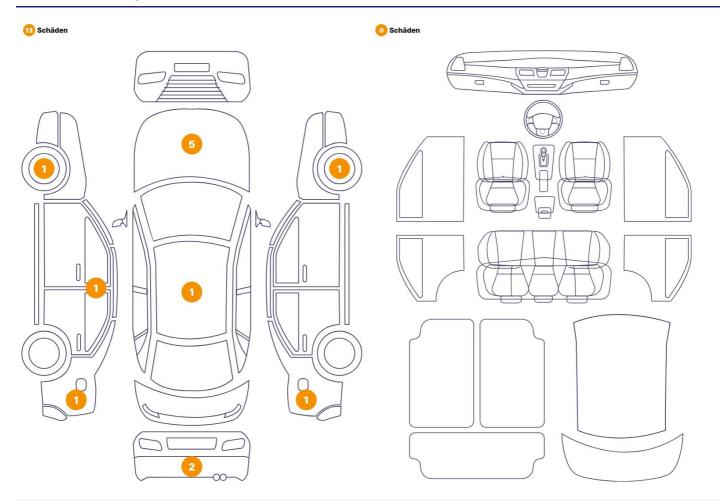
Cosmetic Damage

| | Component | Damage | Comments |
|---|---|---|---|
| 1 | Hood | Bodywork / Dent / Dent | |
| 12 | Hood | Paint / Poor Previous Repair | |
