Expertise

Protocol number: 41382485
Order No. / Reference: 25152200
Inspection date: 29 Aug 2025

Manufacturer: Opel

Model: Grandland 1.5 D Automatik Elegance

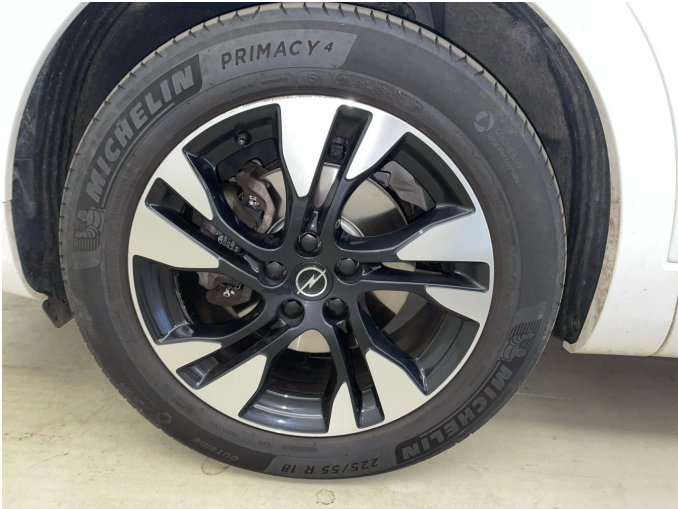
Figure 12: Mounted tyres

#	Tyre size	Type of tyre	Manufacturer	Tread depth
1)	225/55 R18 102V	Summer tyres on Light alloy	Michelin	3mm / 3mm
2)	215/65 R17 103H	Winter tyres on Light alloy	Bridgestone	6mm / 6mm

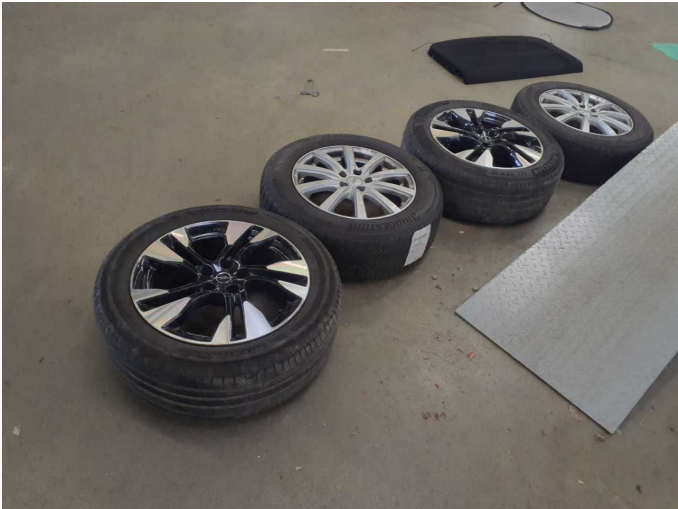
Figure 20: Additional tyres

#	Tyre size	Type of tyre	Manufacturer	Tread depth
1)	215/65 R17 103H	Winter tyres on Light alloy	Bridgestone	5mm / 5mm
2)	225/55 R18 102V	Summer tyres on Light alloy	Michelin	4mm / 4mm
