Expertise

Protocol number: 39830122  
Order No. / Reference: 24685180  
Inspection date: 21 May 2025

Manufacturer: Opel	Model: Grandland X 1.5 D Start/Stop Automatik Business Elegance
VIN: W0VZCYHZ8M6814471

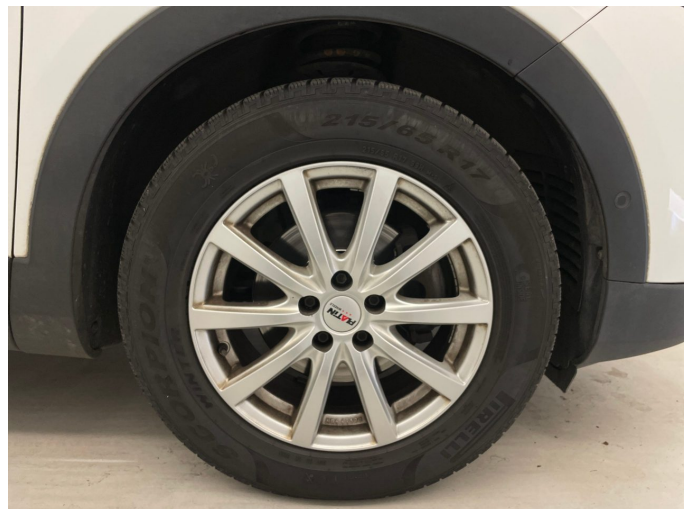
Figure 12: Mounted tyres

- Für den montierten Radsatz wurde kein Nachweis erbracht.
- Winterradsatz ist kein Bestandteil des Auslieferungsumfangs.
