Expertise

Protocol number: 41726822
Order number / reference: 25213190
Inspection date: 25 Sept 2025

Manufacturer: Opel

Model: Grandland 1.5 D Automatik Elegance

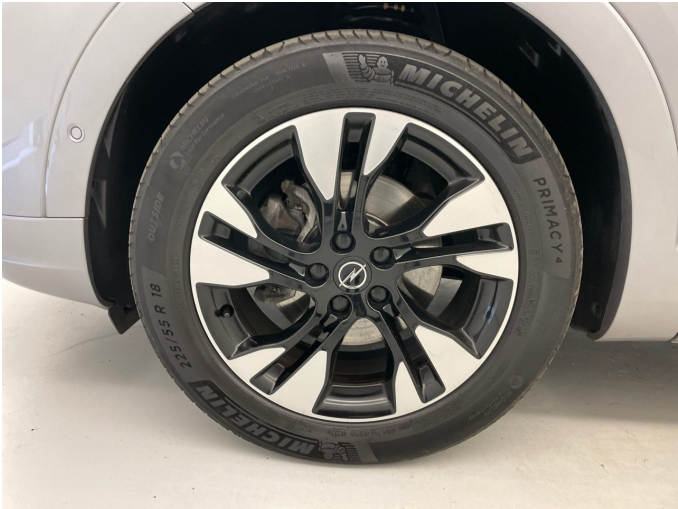
Figure 12: Mounted tyres

#	Tyre size	Type of tyre	Manufacturer	Tread depth
1)	225/55 R18 102V	Summer tyres on Light alloy	Michelin	4mm / 4mm
2)	225/55 R18 102V	Summer tyres on Light alloy	Michelin	4mm / 4mm
