## status report

| <b>customer:</b> | <b>Opel Grosskunden/FSL/Free2Move</b> |

| vehicle data | | | |
|---|---|---|---|
| <b>Opel Grandland GS Line</b> | | | |
| Vehicle identification number | <b>W0VZRHNS8N6802411</b> | mileage read: | <b>54285 km</b> |

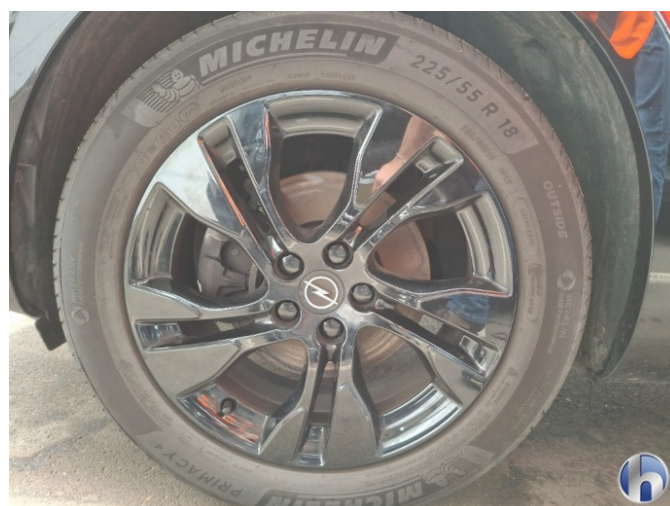
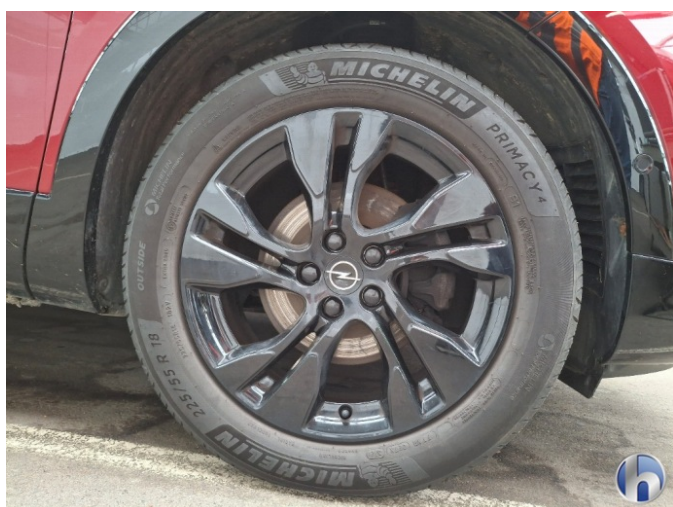
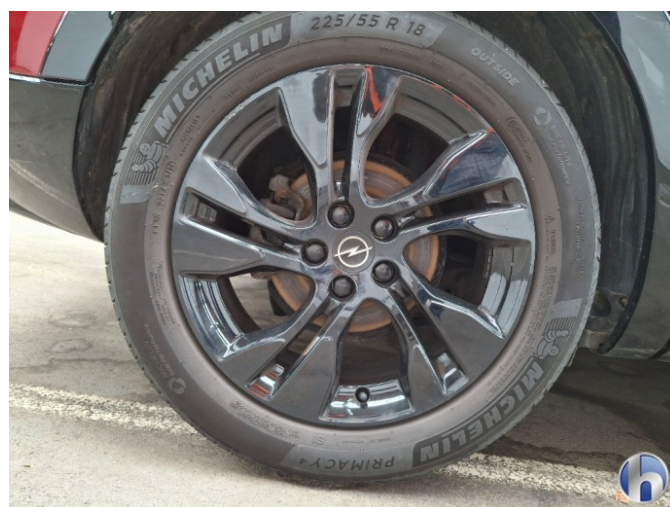
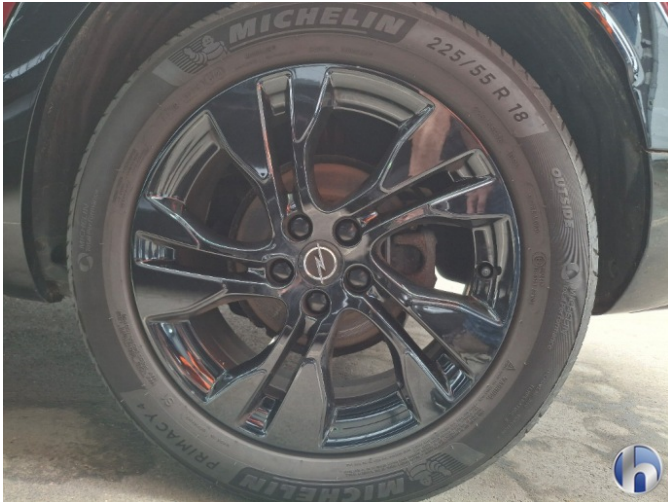
rims

| mounted tires | | |
|---|---|---|
| 1st axis - Left / states . | <b>Pirelli</b> | <b>225/55/R18/102V 3.4 mm</b> |
| 1st axis - right / states . | <b>Pirelli</b> | <b>225/55/R18/102V 3.4 mm</b> |

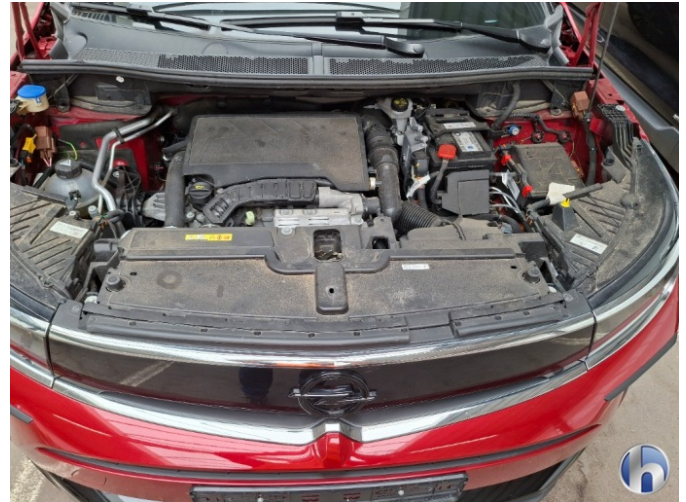
engine compartment

| Performed testing technology | |
|---|---|
| <b>oil loss:</b> | The vehicle was inspected during the visit to an oil leak . |
