Expertise

Protocol number: 41378971  
Order No. / Reference: 25193247  
Inspection date: 4 Sept 2025

| Manufacturer: Opel | Model: Insignia Grand Sport 2.0 Diesel Automatik Business Elegance |

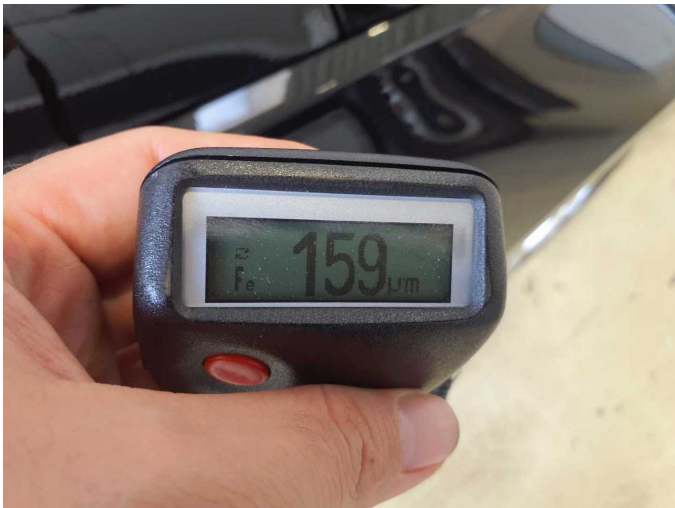
| No. | Repainting |
|---|---|
| 1 | Mudguard - right side, Door - rear right side, Door - front right side, Professionally carried out, Invoice of repair done Non-existent |

**Repainting 1:** Mudguard - right side, Door - rear right side, Door - front right side
