Expertise

Protocol number: 41512496  
Order No. / Reference: 25183375  
Inspection date: 12 Sept 2025

Manufacturer: Opel

Model: Insignia Sports Tourer 2.0 Diesel Business Elegance

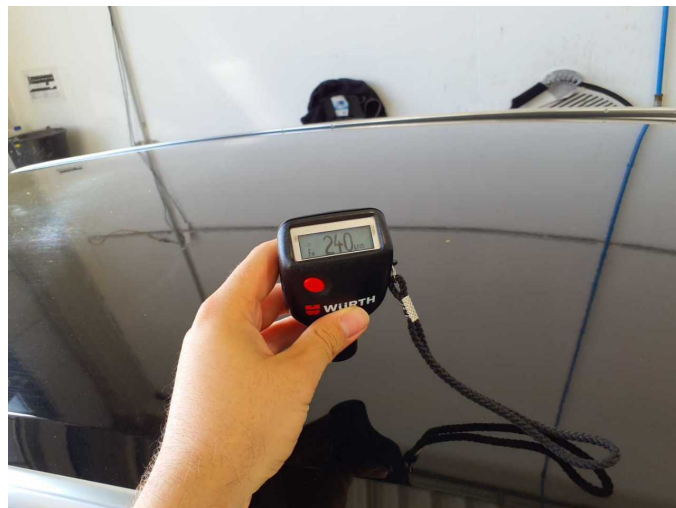
1 Roof, Door - rear right side, Professionally carried out, Invoice of repair done Non-existent

Professionally repaired previous damages were found at the vehicle.

**Repainting 1:** Roof, Door - rear right side
