Expertise

Protocol number: 41323102  
Order No. / Reference: 25098484  
Inspection date: 29 Aug 2025

Manufacturer: Opel

Model: Insignia Sports Tourer 2.0 Diesel Business

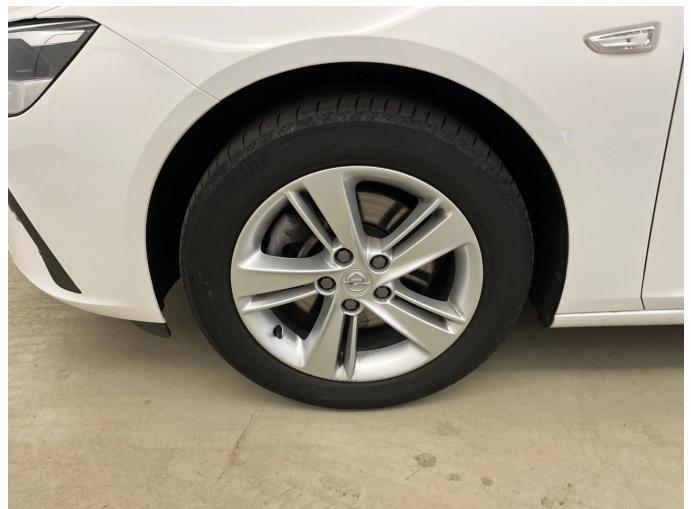
Figure 12: Mounted tyres

#	Tyre size	Type of tyre	Manufacturer	Tread depth
1)	225/55 R17 97W	Summer tyres on Light alloy	Bridgestone	2mm / 2mm
2)	225/55 R17 97W	Summer tyres on Light alloy	Bridgestone	5mm / 5mm

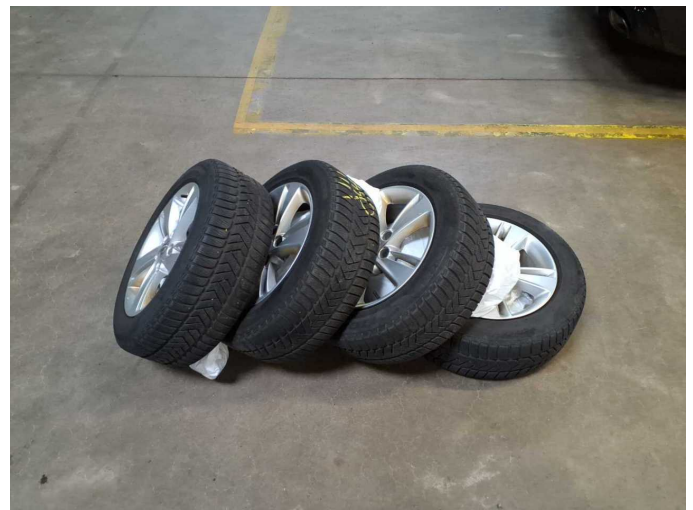
Figure 16: Additional tyres

#	Tyre size	Type of tyre	Manufacturer	Tread depth
1)	225/55 R17 101V	Winter tyres on Light alloy	Pirelli	4mm / 4mm
2)	225/55 R17 101V	Winter tyres on Light alloy	Pirelli	5mm / 5mm
