Expertise

Protocol number: 41552822  
Order No. / Reference: 25232583  
Inspection date: 15 Sept 2025

Manufacturer: Mercedes-Benz  
VIN: W1K2054141G101013

Model: C 220 d Cabrio 9G-TRONIC AMG Line

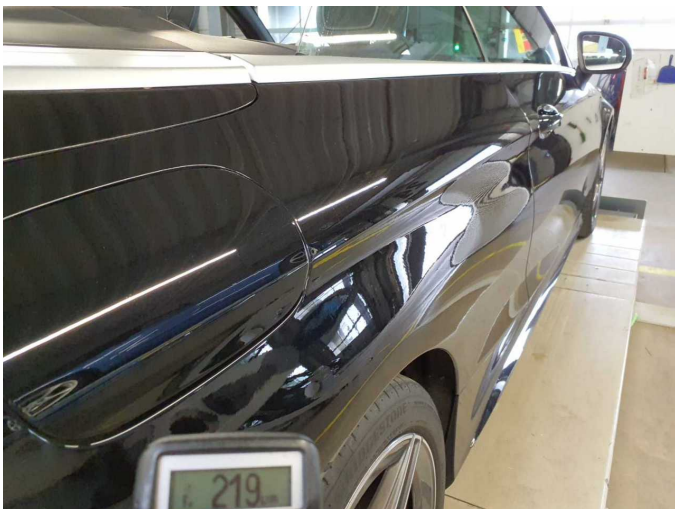
| No. | Component group | Description |
|---|---|---|
| 12 | Side panel - rear right side | Side panel (verformt, wellig, Orangenhaut) - Unprofessionally repaired - Repair and paint |

- 1 Side panel - rear right side, Unprofessionally carried out, Invoice of repair done Non-existent
- 2 Door - front right side, Invoice of repair done Non-existent

**Repainting 1:** Side panel - rear right side
