# MERCEDES-BENZ CLA CLA 250 e Shooting Brake 8G-DCT

VIN NO W1K5M8GB1PN366472 Registration Number B1PN366472

## **Inspection Report Summary**

Customer	BCA Online	Report Number	P20250911101335
Inspection Date / Place	2025-09-11 / BCA Neuss	Cosmetic Grade	4

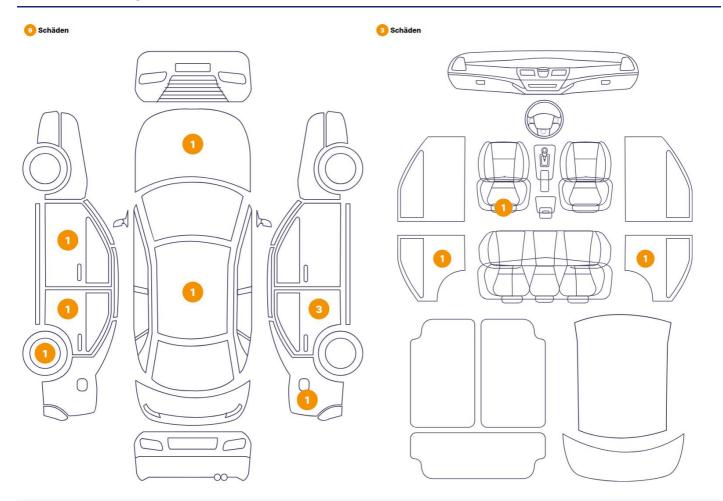
Component	Damage	Comments
1	Seat / Front Left	Interior / Scratched	
2	Pillar / Back Left	Paint / Scratch / Scuff	
3	Panel Filling / Back Left	Interior / Scratched	
4	Pillar / Back Right	Paint / Scratch / Scuff	
5	Panel Filling / Back Right	Interior / Scratched	
6	Fender / Back Right	Paint / Poor Previous Repair	
7	Door / Back Right	Paint / Poor Previous Repair	
8	Roof	Paint / Chemical Damage	
9	Hood	Bodywork / Dent / Dent	
10	Door / Front Left	Bodywork / Dent / Dent	
11	Rim / Back Left	Out of Bodywork / Scratch	
12	Door / Back Right	Bodywork / Dent / Dent
