Expertise

Protocol number: 41251634  
Order No. / Reference: 25106317  
Inspection date: 26 Aug 2025

Manufacturer: Mercedes-Benz  
VIN: W1N2476121W047480

Model: GLB 200 d 8G-DCT Style

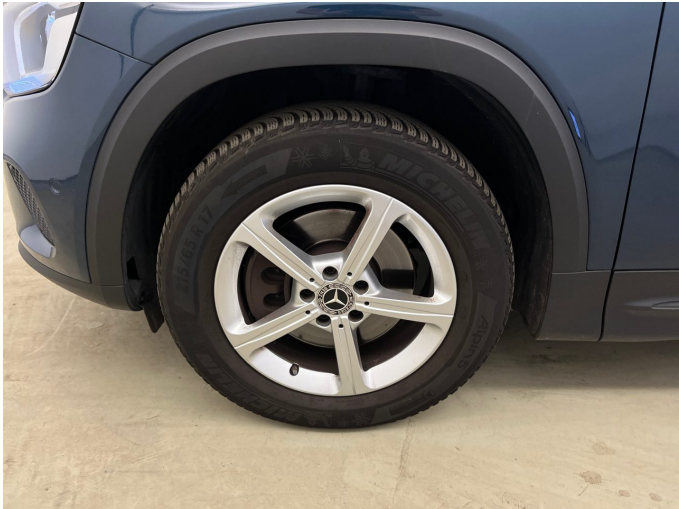
Figure 12: Mounted tyres

| No. | Component group | Description |
|---|---|---|
| 1 | Wheel / tyres | Tyre - front right side (Flanke, nicht fahrtauglich) - Damaged - No deduction |

Der montierte Winterradsatz ist nicht Bestandteil der vorliegenden Fahrzeugausstattung. Nicht fahrtauglich-Reifen defekt.
