MERCEDES GLC - X253 2019 Diesel
GLC 300 de phEV (eq-power) Sport 4matic
auto

VIN NO W1N2539111V314841
Registration Number GG876RV

Inspection Report Summary

Customer	BCA Lodi	Report Number	P20250919163553
Inspection Date / Place	2025-09-19 / BCA Lodi	Cosmetic Grade	3

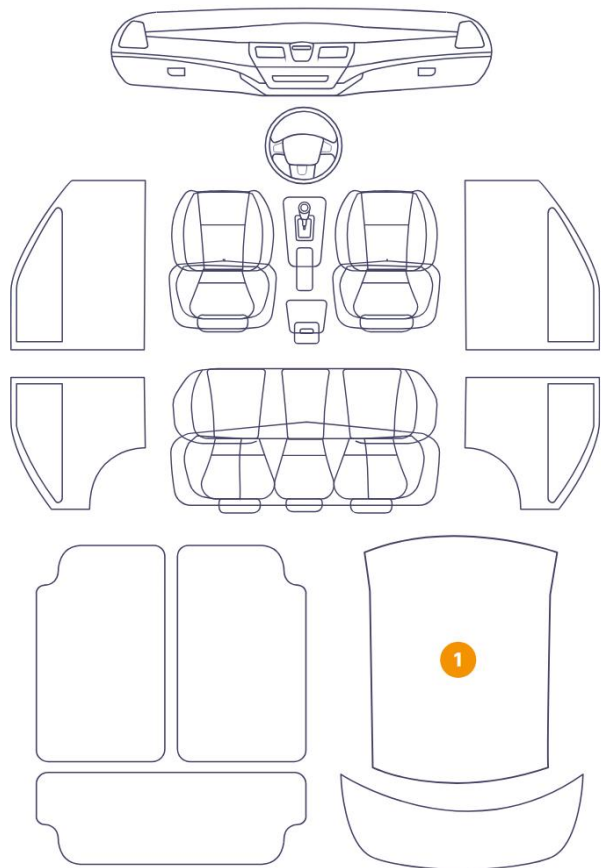
1 Danni

Component		Damage	Comments
1	Roof Upholstery	Interior / Worn - out	
2	Rim / Front Left	Out of Bodywork / Scratch	
3	Fender / Front Left	Paint / Chipping	
4	Door / Front Left	Bodywork / Poor Previous Repair	
5	Door / Back Left	Bodywork / Poor Previous Repair	
6	Fender / Back Left	Bodywork / Poor Previous Repair	
7	Fender / Back Right	Bodywork / Poor Previous Repair	
8	Door / Back Right	Bodywork / Poor Previous Repair	
9	Rim / Front Right	Out of Bodywork / Scratch	
10	Rim / Back Right	Out of Bodywork / Scratch	
11	Rocker Panel / Center Right	Paint / Scratch / Line	
12	Hood	Bodywork / Poor Previous Repair

13	Other	Bodywork / Poor Previous Repair
----	-------	---------------------------------
