Expertise

Protocol number: 41343610
Order No. / Reference: 25129466
Inspection date: 28 Aug 2025

Model: GLC 300 de 4Matic 9G-TRONIC

VIN: W1N2539111V317868

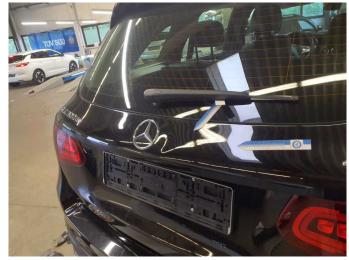
Damage 1: Roof: Roof rail - right side (2 Dellen) - dent(s) - Smooth repair Damage 2: Boot lid / rear door: Boot lid - dent(s) - Repair work

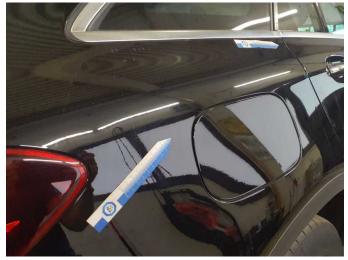
Damage 3: Side panel - rear right side: Side panel - Scratch(es) - Cover / polish

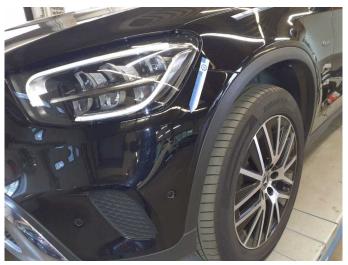
Damage 3: Side panel - rear right side: Side panel - Scratch(es) - Cover / Damage 4: Front bumper: Front bumper - Scratch(es) - Cover / polish
