MERCEDES CITAN  
CITAN FGN 109 CDI LONG

VIN NO W1V4156031U299900  
Registration Number GC701KM

Inspection Report Summary

Customer	BCAuto Encheres	Report Number	P20250711080002
Inspection Date / Place	2025-07-11 / BCA GARONS	Cosmetic Grade	5

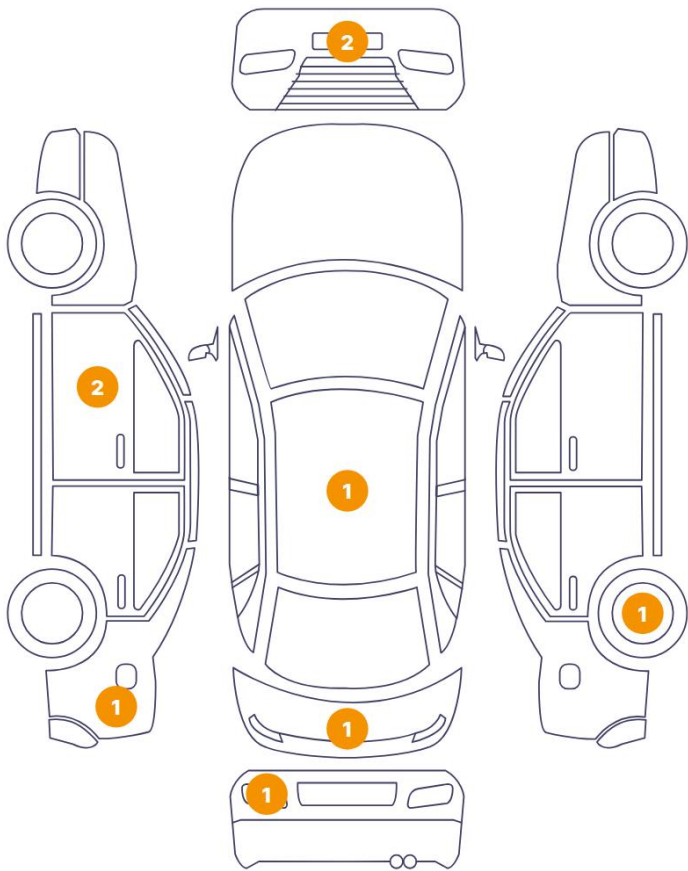
9 Dommages

Component		Damage	Comments
1	Tailgate Upholstery / Back	Interior / Scraped	
2	Trunk Carpet	Interior / Scraped	
3	Tailgate Upholstery / Back	Interior / Scraped	
4	Roof	Bodywork / Dent / Dent	
5	Tailgate	Bodywork / Dent / Deformation	
6	Reflector / Back Left	Bodywork / Breakage / Crack	
7	Fuel Door / Back Left	Bodywork / Breakage / Crack	
8	Door / Front Left	Paint / Scratch / Line	
9	Seat Cushion / Front Left	Interior / Dirty	
10	Seat Cushion / Front Right	Interior / Dirty	
11	Mirror / Front Left	Bodywork / Breakage / Crack	
12	Bumper / Front	Bodywork / Breakage / Crack	
13	Bumper / Front	Missing Part
